New Brancepeth Colliery

A land quality inspection was carried out at New Brancepeth Colliery between January 2018 and October 2019 and subsequent remedial works undertaken in January 2021.

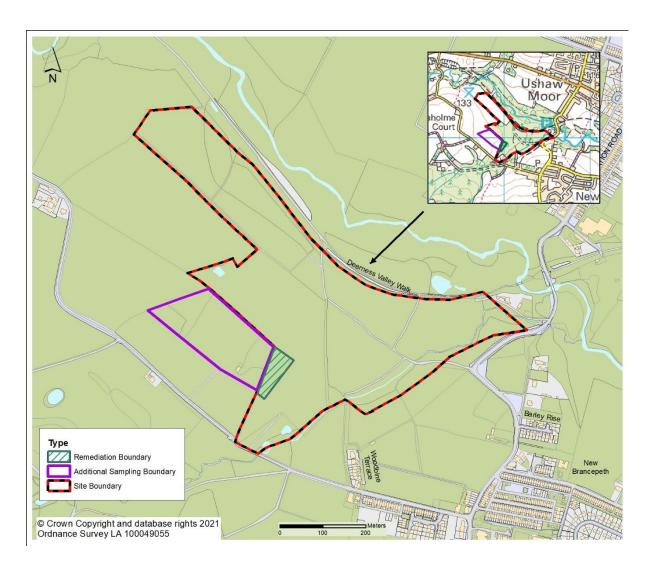
The map below shows the site boundary of the inspection area on this former industrial site. Additional sampling was undertaken on land to the south west, off site of the former colliery, closest to identified as requiring remedial works. No further work was required on the land to the south west though remediation took place in a small area on site, shown on the map.
