Conservation Area Appraisal

Muggleswick

December 2011

*Heritage, Landscape and Design
Durham County Council*

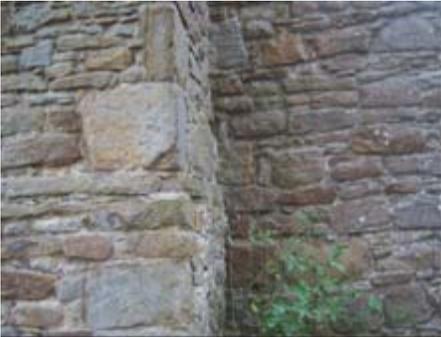
In situ medieval masonry at the Grange ruins.

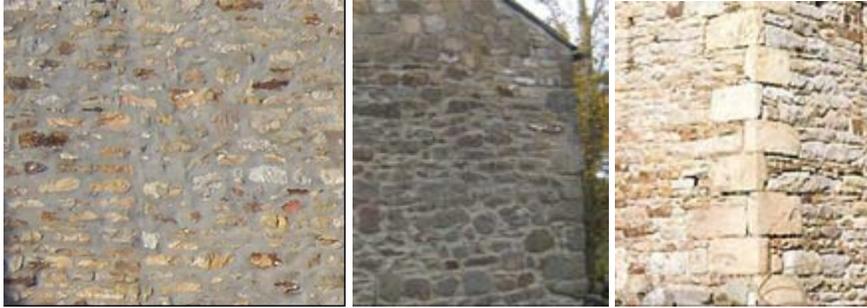
Examples of historic masonry within the conservation area.

Masonry is generally roughly coursed sandstone rubble or more neatly coursed sandstone blocks, usually with quoins. The form of the masonry varies from building to building, and in some cases within the structure of individual buildings demonstrating different phases of construction. The buildings around the Grange incorporate recycled medieval masonry. There is no local tradition of building in brick, although some buildings incorporate small patches of brickwork.

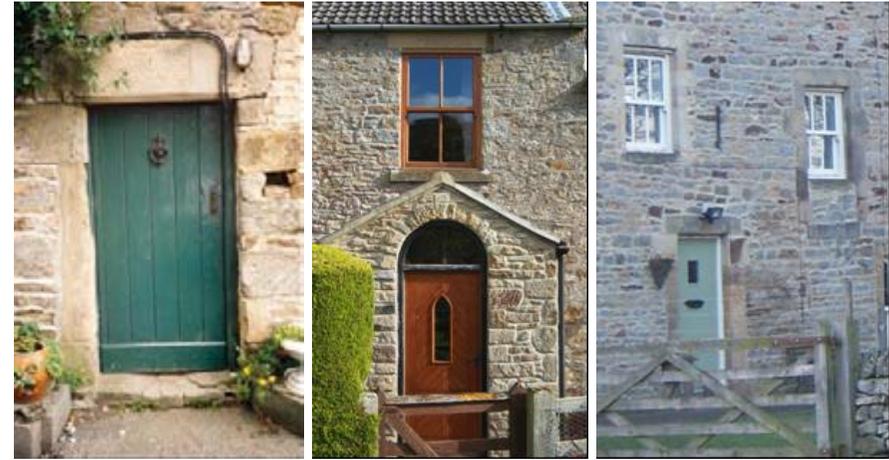
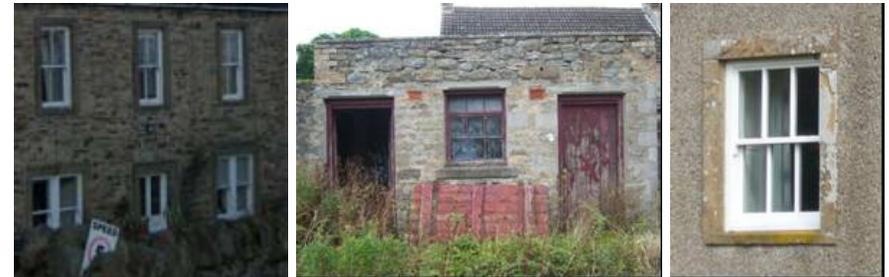
A range of doors and windows of various dates within historic buildings at Muggleswick

Doors and window frames are traditionally of timber, usually painted white though with a natural dark wood finish in some cases. Old photographs demonstrate that agricultural buildings in the past have had door and window frames in blue, red or green; red and green examples still survive. Historic sash windows survive in some properties, while others have been replaced with recent sashes of traditional form. Lane Head has distinctive multi-paned windows unique within Muggleswick but apparently dating back at least to c1900. Several old doorways have stone jambs and lintels, and in some converted properties these old doorways now contain

windows. Windows in older houses are set within plain stone surrounds; others have plain stone lintels and projecting sills.

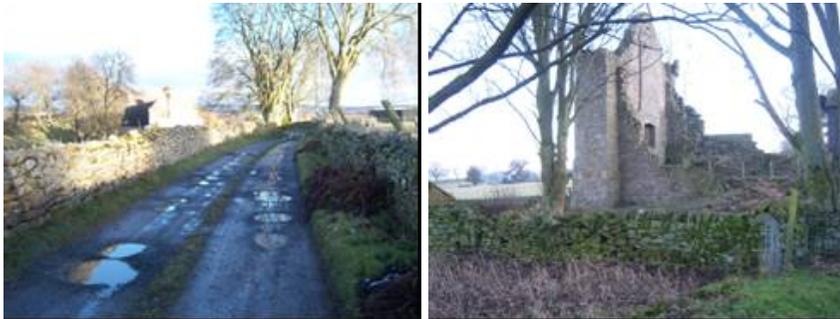
Stone walls at Muggleswick. left: Walls line the track to Grange Farm. right: Multi-phase section of stone wall adjacent to the Grange ruins.

Boundaries in and around the conservation area are almost exclusively drystone walls, and these are absolutely crucial to the character of the conservation area, contrasting markedly with the adjacent open moorland of Muggleswick Park. To the south of the road, the large fields and churchyard are enclosed by stone walls and the road itself is bounded to both sides along most of its length by stone walls, as is the track up the church. Post-and-rail and post-and-wire fences exist in a few places, and wire on timber posts is used in places to heighten stone-walled boundaries (to prevent stock climbing over them), but drystone walls are clearly the main traditional form of boundary at Muggleswick.

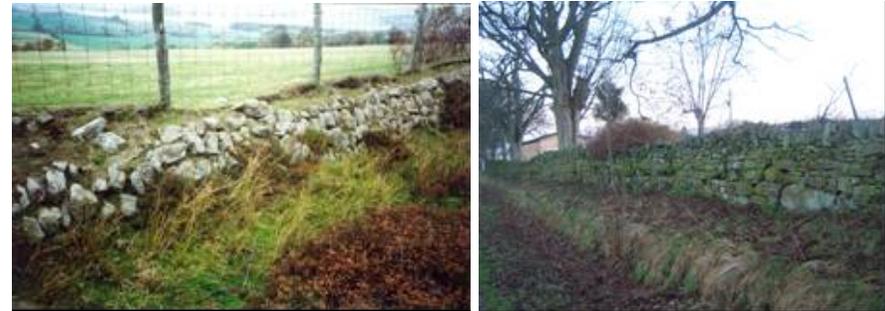
Left: Roadside wall with overlying fence on the line of the medieval park boundary north-west of Lane Head (outside the conservation area) – walls of this form may originally have been hedgebanks and may well have medieval origins. Right: Roadside wall incorporating large boulders, south of Sunny Bank.

The walls are generally of similar form, of locally quarried sandstone with roughly shaped coping stones, but in some places exhibit different forms. The walls extending from the gated entrance to Lane End are largely moss-covered, lending them a uniquely attractive appearance. A detailed study of stonewalls around Muggleswick may well prove fascinating, perhaps allowing different styles to be dated to different periods. Gateways in stone walls are of various forms, some with stoops and others without. Gates are also of various types, some timber and others metal.

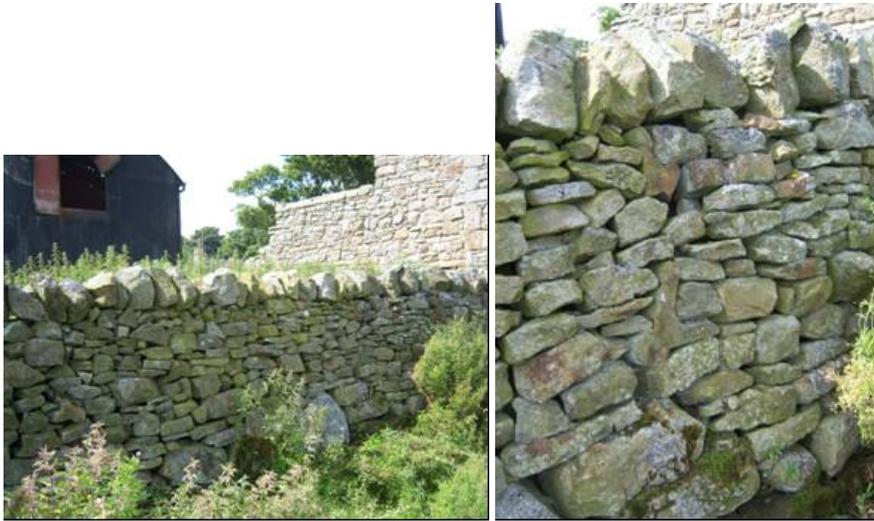
There is a high potential for stone walls at Muggleswick to contain worked stone from the medieval grange. This section of wall adjacent to the Grange ruins contains several ridge stones from the medieval roof.

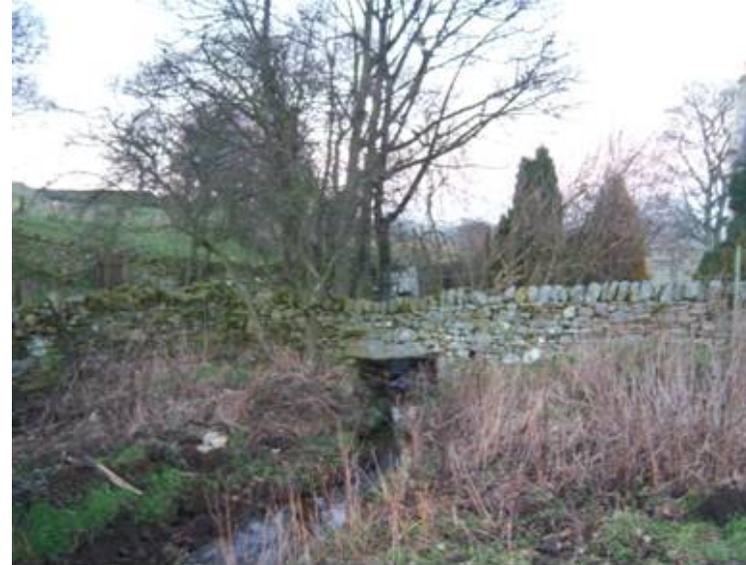
The Muggleswick Burn passes under a stone wall adjacent to Priory Farmhouse

The Muggleswick Burn flows along the road's wide north verge between Lane Head and Priory Farm, passing through an open grassed area (sometimes used for car parking) in front of Priory Farmhouse before turning away from the road and passing to the north through a gap under a stone wall.

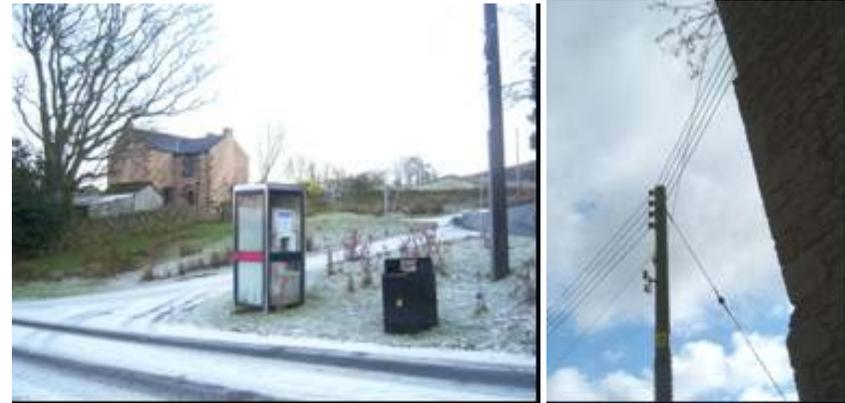
Left: Telephone box, litter bin and telegraph pole at the junction of the Muggleswick road; Sunny Bank behind. Right; overhead cables adjacent to the Grange ruins.

Overhead power and telephone cables, mounted on timber poles, extend along the roadside, passing immediately adjacent to the ruins of the Grange. These undeniably detract from the historic setting of the ruins.

- The possible undergrounding of unsightly overhead power and telephone cables, and the possible replacement of the modern telephone box with a historic red kiosk.

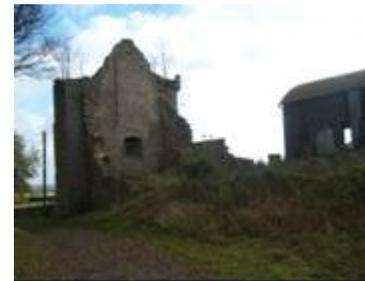
Remains of lodge and grange of manor of Muggleswick. C13 for Hugh of Darlington, Prior of Durham 1258-72. Sandstone rubble with quoins and ashlar dressings. L-plan west part, and much of 3 sides of east part, of long range, linked by early C20

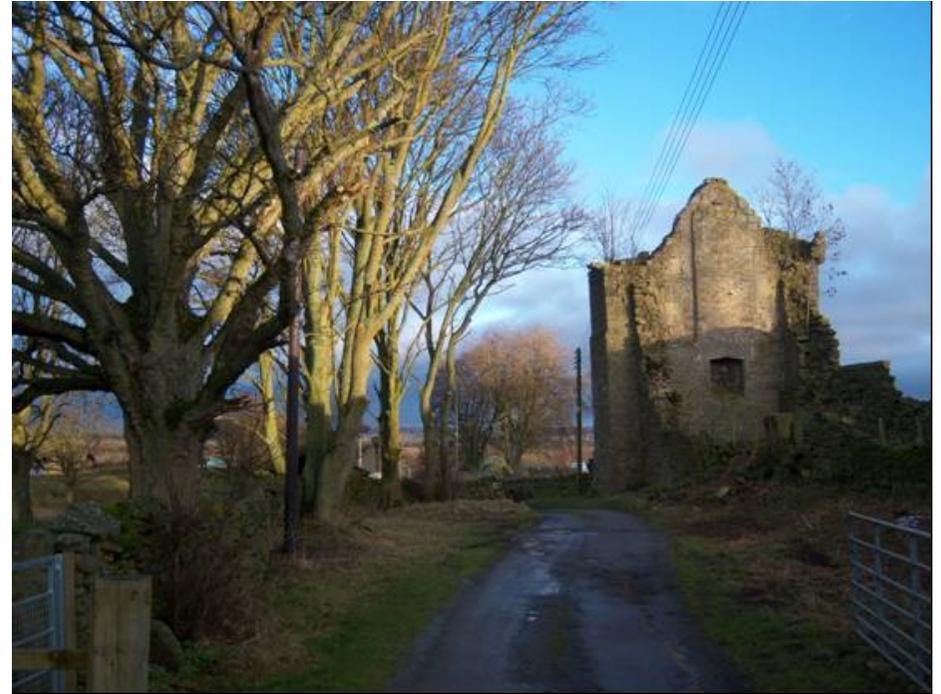
The Grange ruins from the road, showing the west (internal) face of the east gable of the east block.

The Grange consists of parts of two separate but conjoining east-west blocks. The eastern block measures 18 by 8.5 metres externally and is built of coursed stone ranging from rubble to larger blocks, with large roughly-shaped quoins and dressings. The east gable end survives largely complete, standing to a height of 13m. It is flanked by a pair of solid turrets each of which had oversailing parapets carried on rows of block corbels. The wall between the turrets contains the remains of a large window c1.8m wide and 5m high, with a semi-circular head and chamfered surround. Oddly, this now contains the head of what appears to a rather grand 14th century window. From the interior (west) elevation it is clear that the original window has been used as the flue for a fireplace (of possible 16th-century date), with the fragment of 14th century window presumably introduced from elsewhere to function as the vent or smoke-exit. It is assumed that the first floor here, with its large east-facing window, was originally the grange chapel. Substantial remains of the north and south walls of this block survive adjacent to the east gable, but become progressively more tumbled towards the site of the west gable, of which nothing survives above ground. Several windows, at original basement and first-floor levels, and at least one doorway survive within the north and south walls. Other internal features may survive at ground floor/undercroft level, as the interior is currently filled to a level of c1.5m with fallen debris.

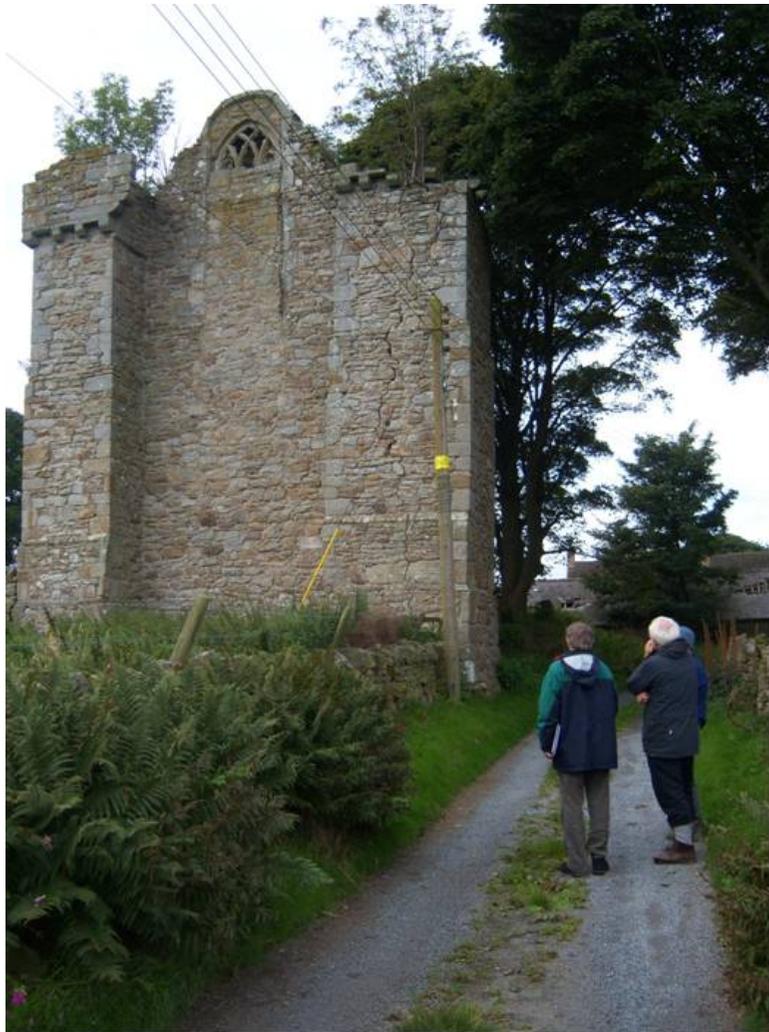
The east (external) face of the east gable of the Grange's east block.

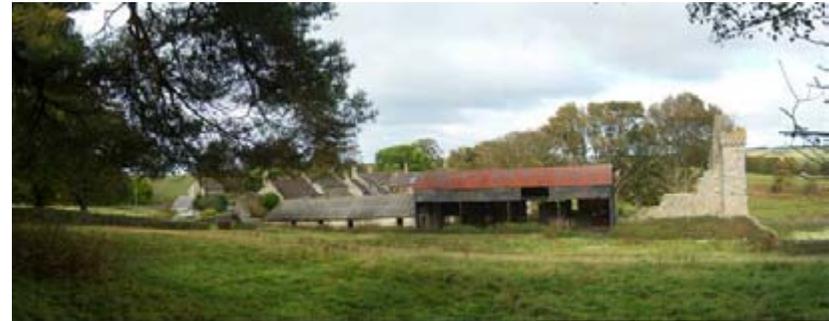
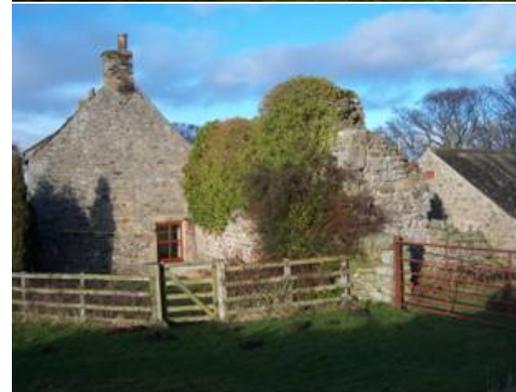
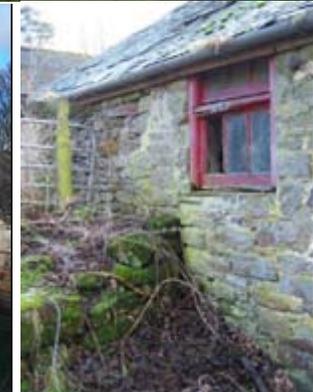
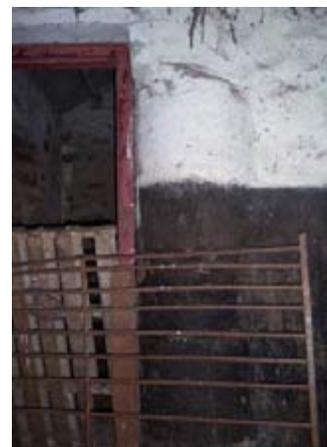
Top: West and east blocks of the Grange seen from the churchyard to the south.

Mid left: The ivy-clad west gable of the west block of the Grange, in the garden of Priory Cottage.

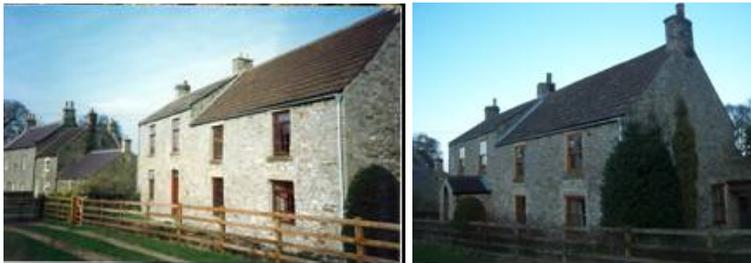
Left: Priory Cottage in 1990, prior to addition of porch. (Photo: M Sobo). Right: Priory Cottage in 2008.

Opposite Priory Farm, south of the road on a north-south axis fronting the track to the church, is Priory Cottage. This is a two-storey, four-bay house of two halves. The northern half, of two bays, is of stone rubble with a concrete tile roof, of approximately 45 degree pitch, and has gable stacks and parapets. The windows are recent sashes, stained brown, and the main door is set within a recent stone built porch. The southern half, which has thicker walls, maintains the same roof ridge line and also has a concrete tile roof, but has lower eaves hence the roofline is steeper, suggesting that it may originally have been heather-thatched. The south gable has no parapet like those on the northern half of the building, and has a brick chimney. The southern half appears earlier, its location suggesting that it may originally have been built while the west end of the Prior's hall and camera (vaulted chamber) was still standing, conceivably during the 17th century.

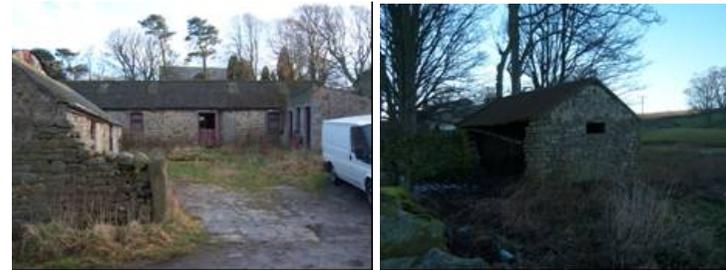
Left: Agricultural buildings east of Priory Cottage. Right: Ruined building north of camera ruins.

multi-paned window frames. The blocks to the east and west of the courtyard, with Welsh slate roofs, appear to have been agricultural workshops, but are now in a poor state of repair and used only for storage. To the south is a long stable block, with asbestos roof. This is of interest as it appears to sit directly on top of the undercroft of the west block of the Prior's camera, and actually incorporates an 'in situ' column of the medieval undercroft in its eastern internal cross-wall.

On the north side of the road, opposite the east end of the camera ruins, is a small dilapidated single storey stone structure with its south wall demolished, presumably to enable its use for agricultural storage. It is of sandstone rubble with crudely formed quoins, and currently has a roof of rusty corrugated iron.

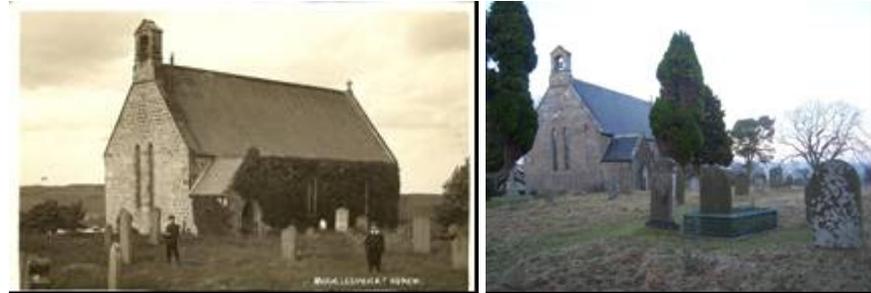
left: Muggleswick Church from the south-west, c1900. (Source: M Sobo archive). right: Similar view in 2008 (note Mayer tomb with railings).

Muggleswick Church is a key building within the conservation area occupying the summit of a low hill to the south of the camera ruins. Although a church is recorded here as early as the 13th century, and one may have stood here in earlier times, the present structure dates entirely from the 19th century. It is a plain building, of local stone (much of which was presumably reused from the earlier church) with a Welsh slate roof and a simple bellcote with single bell extending above the west gable. The entrance is via a simple stone porch. The south elevation has five lancet windows (two paired and one single), and a pair of lancet windows are in the west gable directly beneath the bellcote. The east elevation has a triple window, with stained glass. The north elevation incorporates two further pairs of lancet windows, and a vestry with a substantial stone chimney, the roof of which extends, with a slight change in angle, from the main church roof. Most of the interior fittings are of 20th century date, and are mostly associated with the Ritson family.

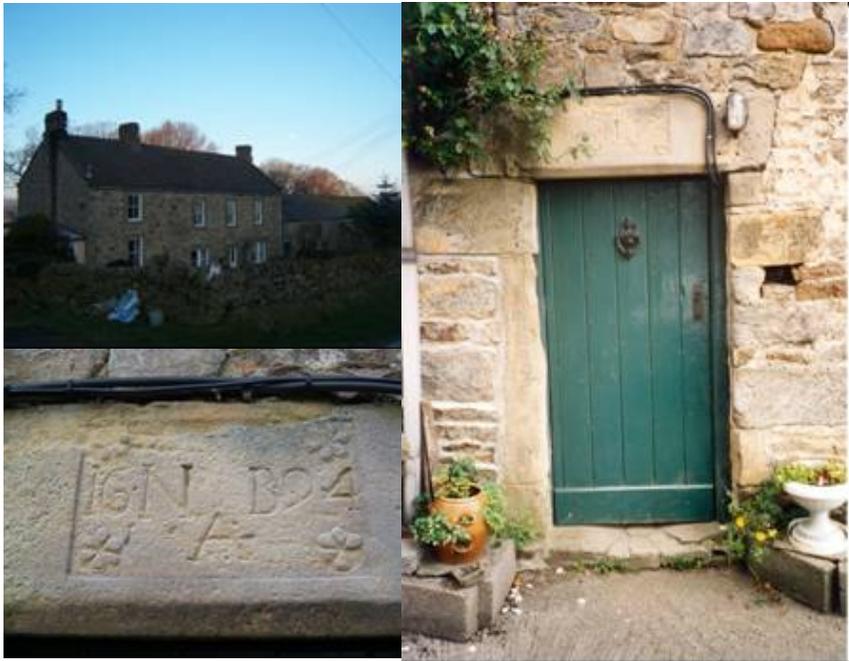
Grange Farmhouse, late 17th century doorway with datestone above (photographed in 1999 by M Sobo). Detail of datestone in 2008, showing erosion

The attached range to the east looks to have been much rebuilt in the later 18th century. The dated doorway here is an important survival; it has long-and-short left jambs and an alternate-block right jamb. The front elevation incorporates several openings for doors, pitching holes and windows on both ground and first floors, with all woodwork painted green in contrast to the white of the adjacent house.

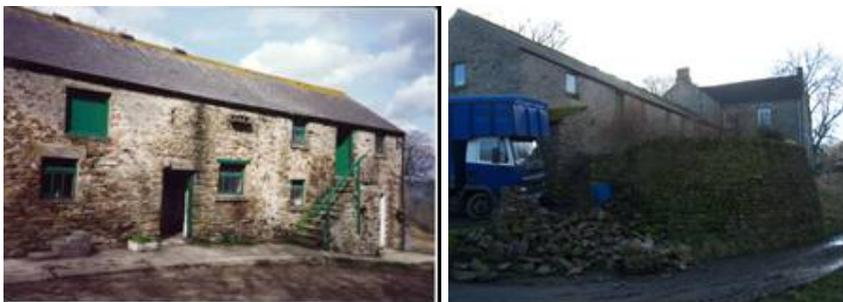
Agricultural range, east of the house, in 1999 (Photo M Sobo). Remains of gin gang on north side of east range.

Pigeon holes and shelves survive at the centre of the elevation, at first floor level. Substantial stone steps lead to a first-floor boarded Dutch door towards the east end of the range. To the rear, a low circular gin-gang wall survives behind the east end of the range, but this is currently in a precarious condition and in serious danger of collapse.

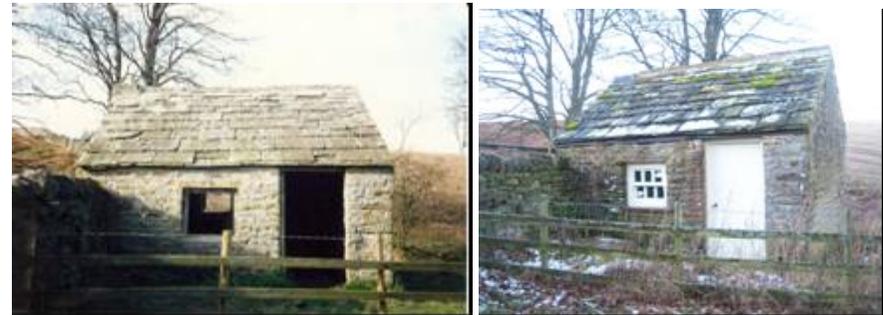
The Old Smithy in 1996 (Photo M Sobo), and in 2008 after conservation.

Moving to the west end of the conservation area, the old smithy, recently conserved with new door and sash window to its front elevation, stands north of the road on the south bank of the Muggleswick Burn. This is shown as a smithy on the 1st edition Ordnance Survey map of c1860, and probably dates originally from the early 18th century. It is a very small single-storey building of sandstone rubble with some crudely formed quoins, and roughly worked window sill and lintel. The door extends to eaves height, and thus has no lintel. The roof is of stone flags, with no chimney (although one did formerly exist in the west gable). A small drystone-walled enclosure extends from the west gable.

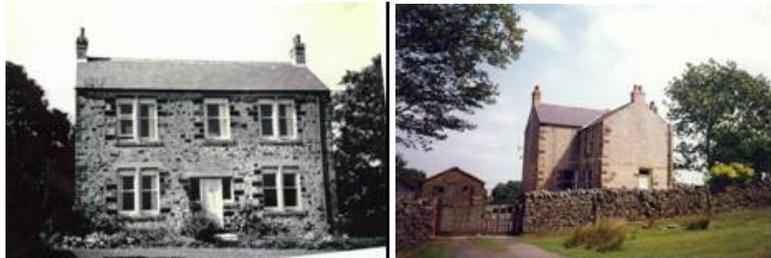
Sunny Bank. Top left: Front elevation, 1950s. (Source: M Sobo archive) rear elevations, 1993 (Photos: M Sobo).

On the south side of the Muggleswick road, within its own extensive private and mostly lawned grounds, is the property known as Sunny Bank. This does not appear on OS maps of the 1920s, but is shown on maps from the 1950s; it is thought to date from the 1920s or early 1930s. It is perhaps the least traditional of all Muggleswick's stone buildings, being L-

shaped in plan with a Welsh slate roof. It has chimneys in each of its three gables, all of which are of brick in contrast to the surviving stone walls – this is presumably a response to the tendency for some kinds of stone to suffer damage through sulphate attack from the smoke generated by coal fires. It is built of random stone, with thin quoins set in alternating pairs and stone window settings which to an extent echo this pattern. The quoins and window stones appear to be of different stone from the rest of the structure. Old photos show much of the stone (and brick) work to have been rendered; perhaps the original builders always intended the walls to be rendered, thus hiding the untidy mismatch of stone and brick work. A rather untidy group of timber outbuildings clusters to the north of the house.

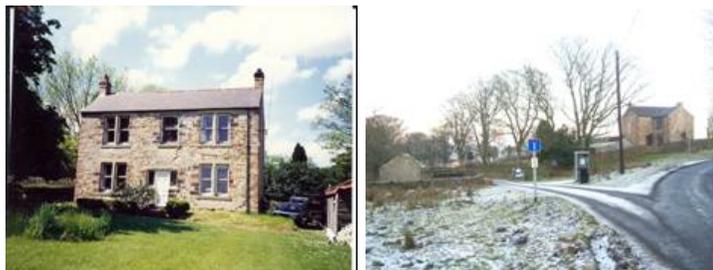
Left: Front elevation right: the house occupies a key location above the junction of the Muggleswick road (the other building is the Old Smithy).

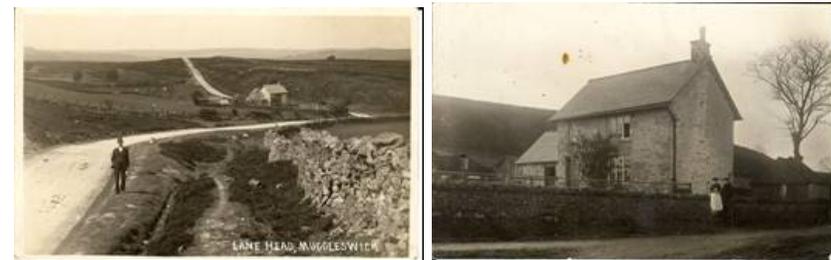
Lane Head Top: Distant view of the house c1900 (Source: M Sobo archive). Bottom: The house c1900 (Source: M Sobo archive).

Lane Head, surrounded by the mature trees and shrubs of its attractive gardens, stands on the opposite side of the road to the west of Sunny Bank. This is a substantial enlargement of the house shown in photographs of about 1900, which itself appears to be of 19th century date. Its multi-paned windows pleasingly echo the style of those of the old house throughout. It is rendered and painted white, with Welsh-slate roof. Old photographs show the original house to be of random rubble with plain stone sills and lintels.

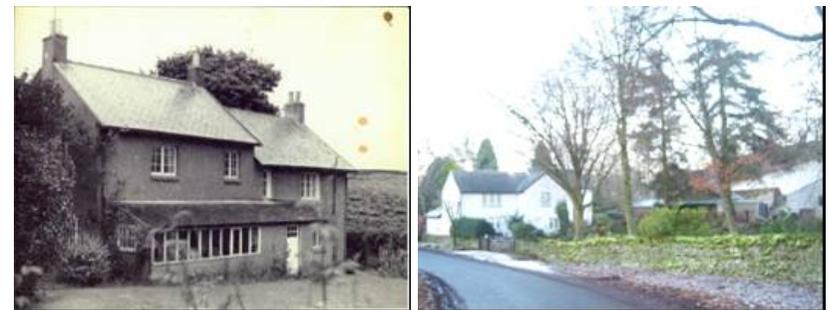
Lane Head. Top: The substantially enlarged house in the 1950s (Source: M Sobo archive). Bottom: The house from the north, 2008.

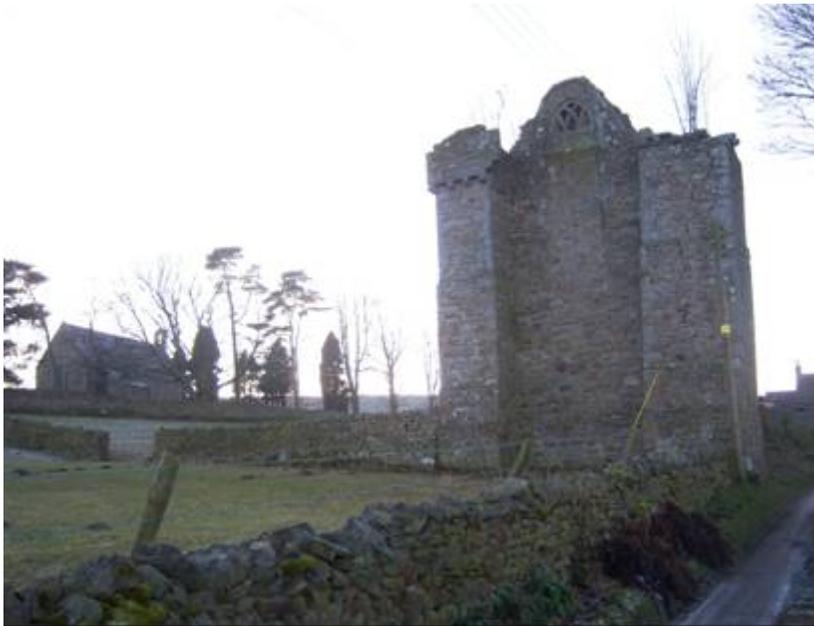
The Grange ruins and the much later All Saints Church

constructed at 'Muclingwic' by Brother William of the Priory; this may have been constructed of timber. In the mid 13th century, perhaps in the 1260s, Prior Hugh de Derlington erected a 'camera' (Latin for 'vault' or 'arched chamber', implying a substantial stone structure) at Muggleswick, presumably on or adjacent to the site of Brother William's house, and it is the ruins of this that survive today as 'Muggleswick Grange'.

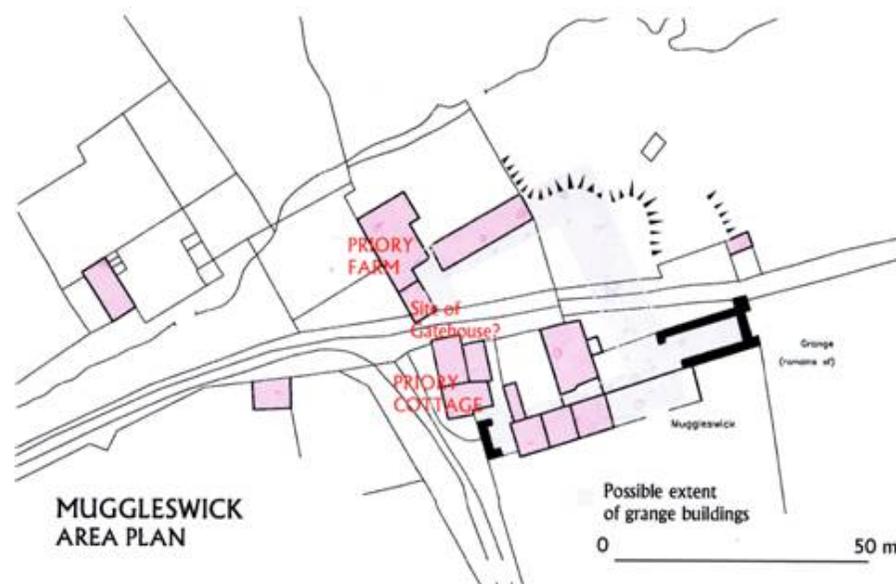
Plan by Peter Ryder showing possible extent of medieval Grange buildings.

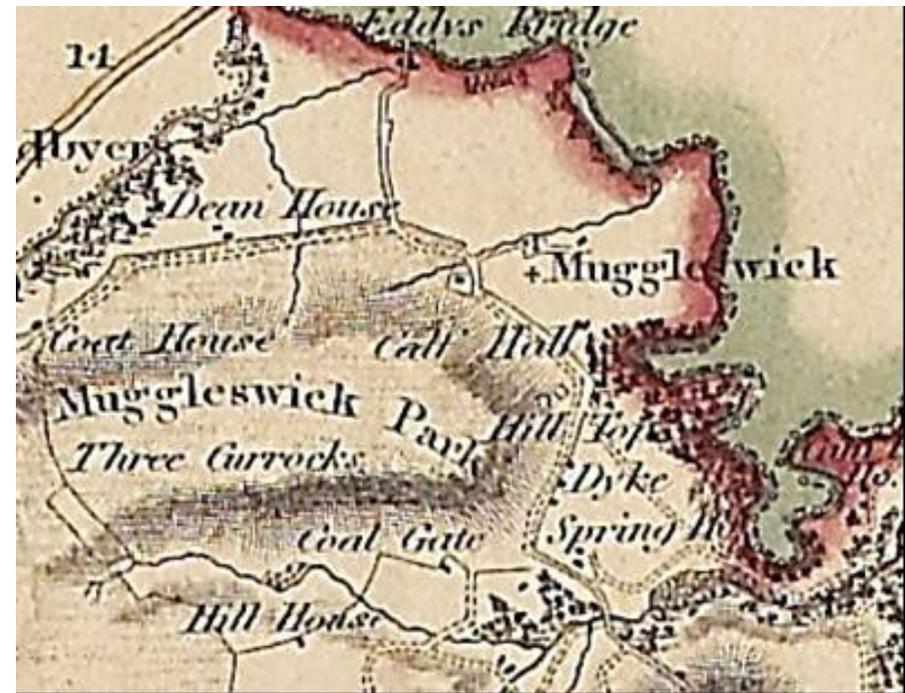
The earliest map to give an indication of the form of Muggleswick is Greenwood's of 1820, which shows a few buildings (presumably Lane End, Priory Farm, and Grange Farm) along the line of the Muggleswick Burn.

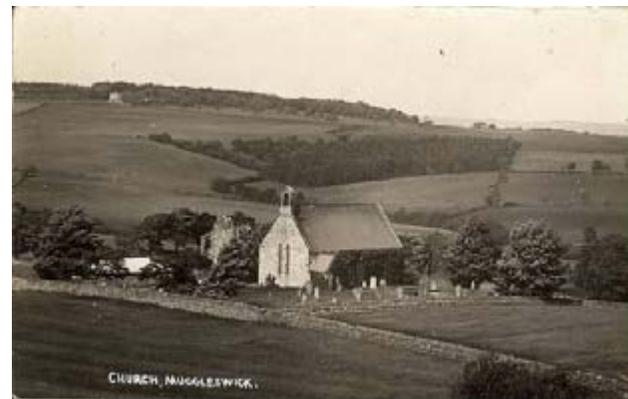
Early 20th century view of Muggleswick Church from the south-west, with the Grange ruins visible behind. (Source: M Sobo archive).

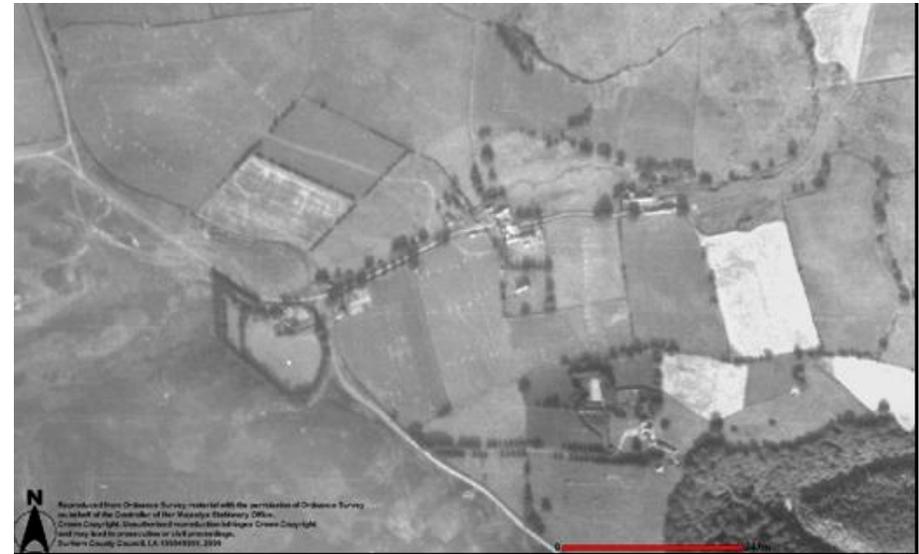
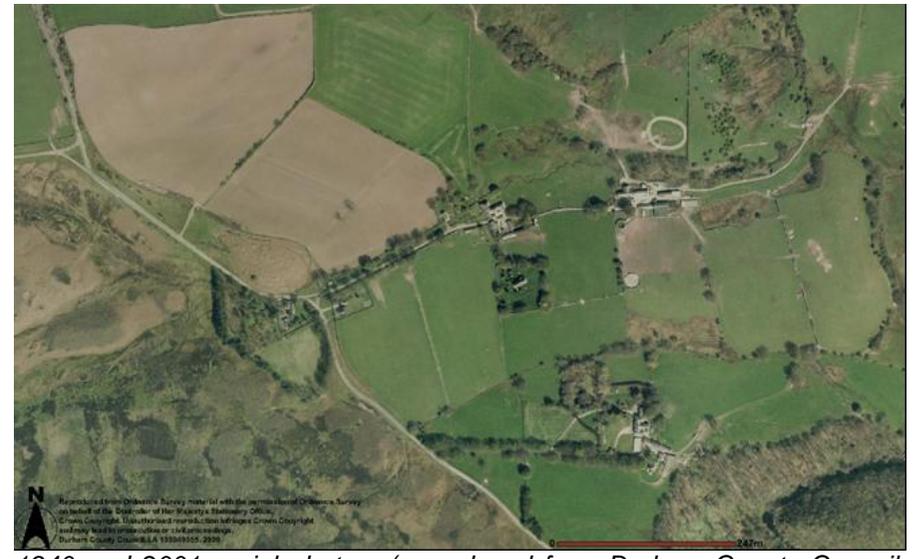
Ordnance Survey maps from the 1890s (top) and c1990 show little development during the twentieth century

1940 and 2001 aerial photos. (reproduced from Durham County Council GIS)

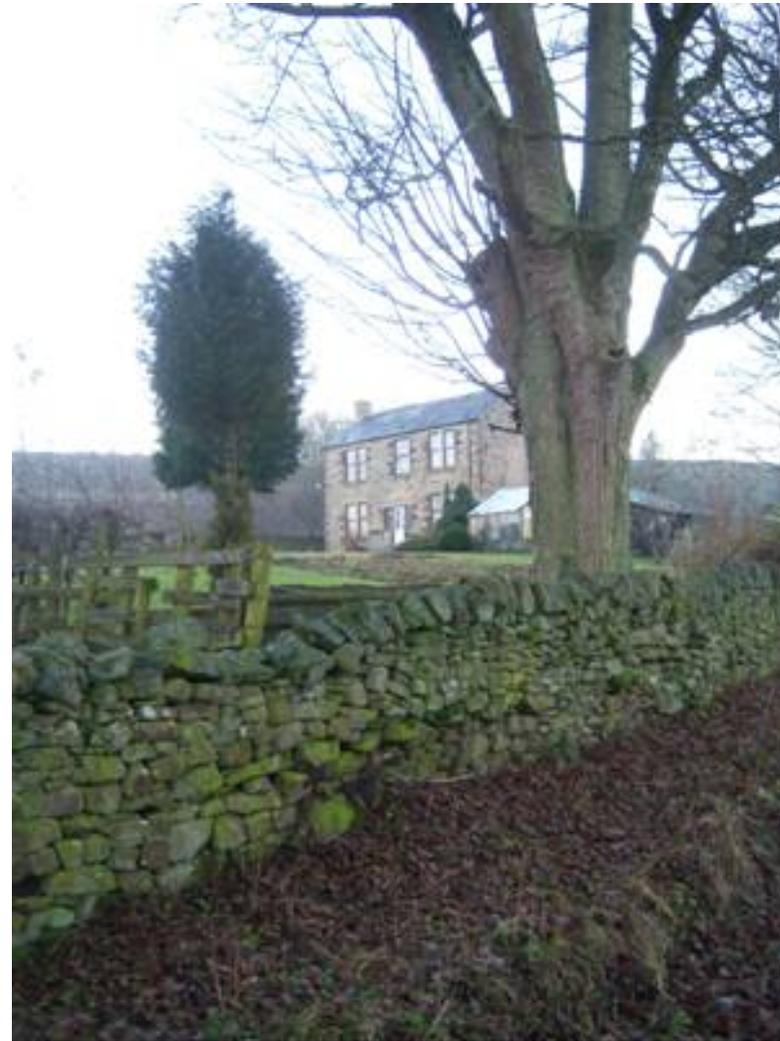
Sunny Bank, the only twentieth-century house in the conservation area.

The church was reopened in 1911 after being '*renovated and richly adorned*', but the works seem to have been largely internal, with little change to the building's outward appearance. The only substantial new stone structure during the 20th century was the house known as Sunny Bank, apparently dating from the 1920s or 1930s. The lack of subsequent development is clearly illustrated by the OS maps and the aerial photographs from the 1940s and 2001 shown above. More recent buildings include substantial equestrian sheds and other outbuildings at Grange Farm, and a small timber stable block south of the road between Sunny Bank and Priory Farm.
