Conservation Area Appraisal

Newbiggin

December 2011

Designated 1987
Boundary amended December 2011

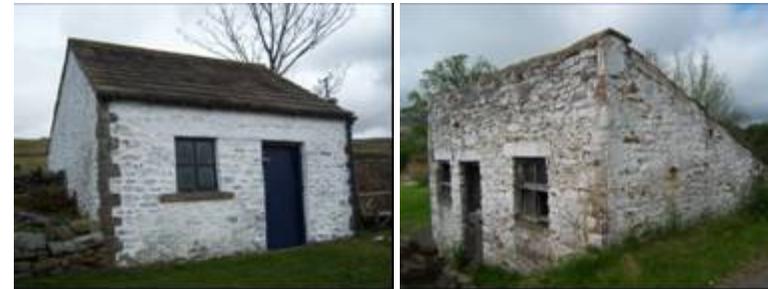
Outbuildings add to the character of Newbiggin. Many appear to be abandoned, while others are used for storage. They are generally built from roughly coursed sandstone rubble. Many are painted white, and several have attractive stone flagged roofs

Several outbuildings are set along Miry Lane and the track up to Brookside. Although individually unremarkable, collectively these outbuildings are an important element of the village landscape. Similar outbuildings stand in several other places throughout the village, many unfortunately in poor and rapidly declining condition. Some retain original stone slate roofs.

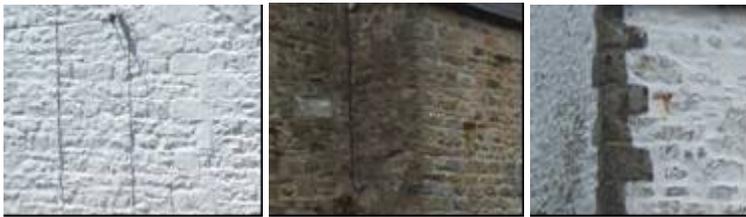
Masonry is generally roughly coursed sandstone rubble or more neatly coursed sandstone blocks usually with substantial quoins.

Historic masonry patterns

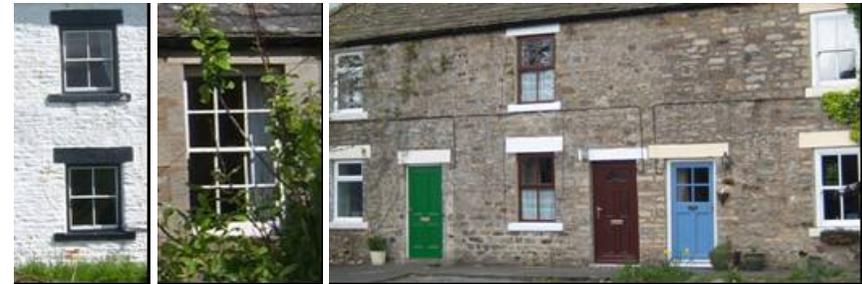
Surviving historic doors and window frames are wooden and are now usually painted white. Many historic sash windows survive in older properties but some have been replaced by a range of alternatives including modern sashes or mock-sashes and in uPVC. Windows are generally set between plain stone lintels and projecting sills. On the whitewashed properties sills, lintels and door jambs are often painted in various shades of blue, whereas on the bare stone properties they are either painted cream or left unpainted.

Traditional windows and Shiny Row with its mix of doors and windows

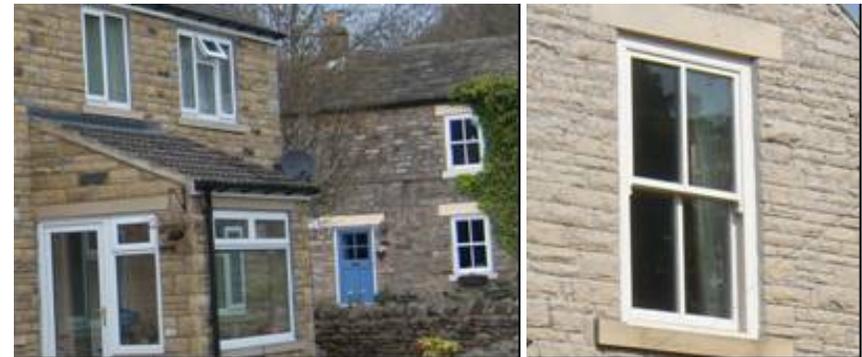
Modern windows in a modern house and a traditional style in a new extension

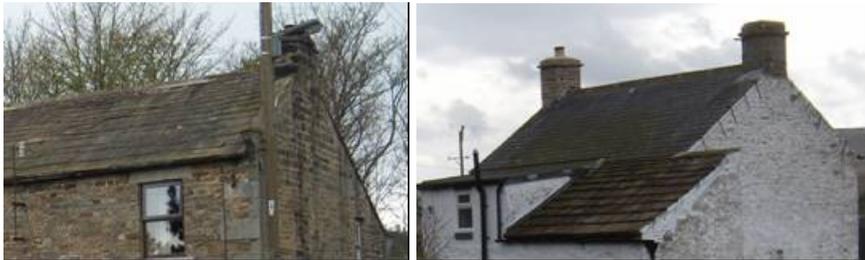
Stone-flagged roofs

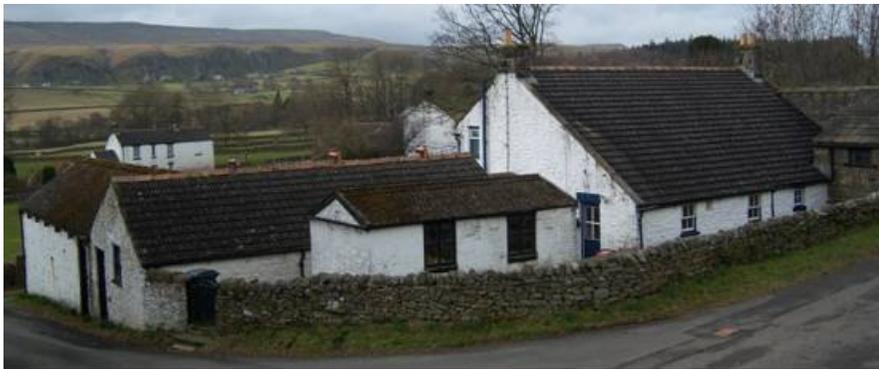
A variety of roofs including stone flags, tiles, artificial slates with red ridge tiles and corrugated sheeting at Pleasant View

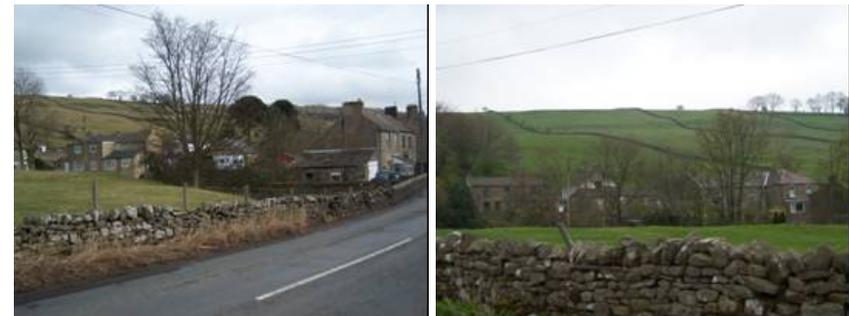
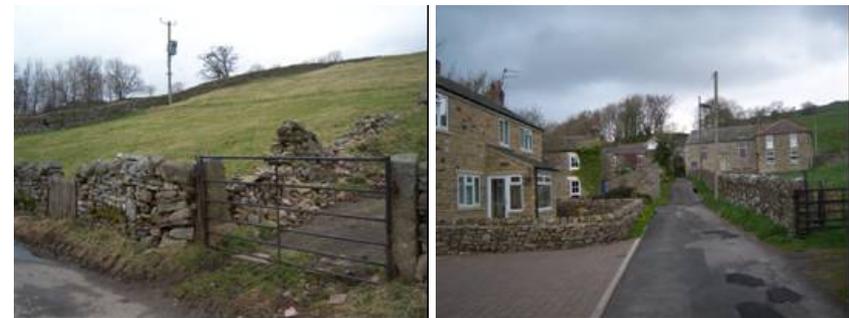
Stone walls, both within the village and throughout the surrounding landscape, are crucial elements of Newbiggin's character binding the various elements of the village together and merging it with its surrounding landscape. They exist in a variety of forms, but are mostly drystone and undulate over the rolling topography. Most walls appear to be in generally good condition. In some places they are surmounted by post and wire fences for more effective stock-proofing. There are some short stretches of timber fencing within the settlement, although most boundaries remain traditional, low stone walls.

Traditional drystone walls, alongside roads, between fields and around properties, are key elements of the village landscape

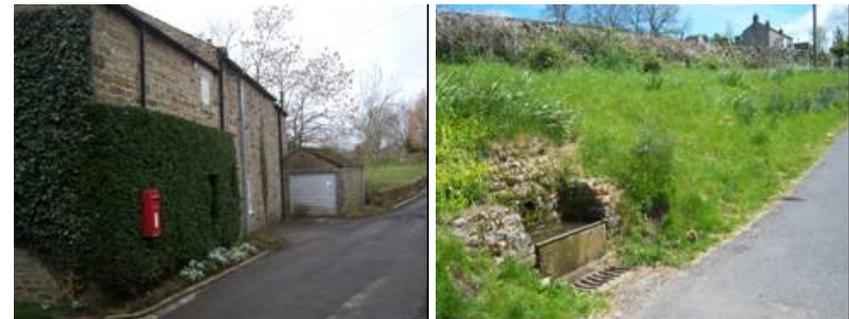
A water trough, fed by a natural spring, is built into roadside verge north of Pleasant View. An old stone drinking trough lies on the grass verge to the east of the road up to The Mill.

The post box and the water trough, Mount Pleasant

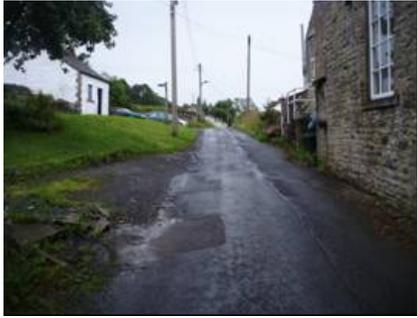
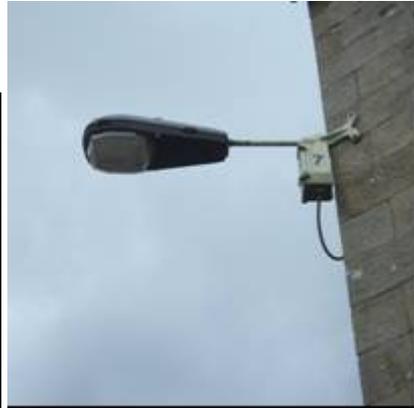
A network of telegraph poles supports overhead electricity and telephone cables throughout the village, many doubling-up as lamp posts. An additional light is attached to the south-west corner of the chapel. Collectively, these poles and cables detract from the character of the conservation area.

Overhead cables and street lighting

- Undertake a landscape survey of the conservation area and prepare a management plan which protects the long term wellbeing.
- Promote the undergrounding of overhead cables if technically possible.
- Replace the railings on the wall around the chapel forecourt.
- Monitor erosion of traditional details, and consider whether an article 4(2) direction removing householder permitted development rights is needed to preserve the character and appearance of the area.

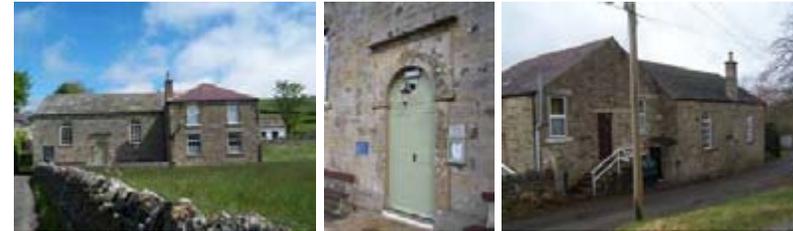
METHODIST CHAPEL

Wesleyan Methodist Chapel. 1759, enlarged 1860. Pecked sandstone ashlar front, rubble left return and rear with ashlar dressings and millstone grit quoins; plinth. Roof of graduated green slates. One high storey, 3 bays. Wide step to central 4-panel double door in keyed round-headed surround; impost blocks form base of high corniced panel over door, inscribed WESLEYAN CHAPEL ERECTED 1760 ENLARGED 1860, in Roman capitals. High flanking windows have keyed round heads with voussoirs, and stone sills, all projecting. Left return has blocked window with flat stone lintel; rear has 2 round-headed windows; all windows have glazing bars. Interior shows west pulpit with single side steps, and short communion rail on flower-patterned wrought iron balustrade, brought from Bowlees Methodist Chapel. Simple pulpit, with raised fielded panelling, in north-west corner original to the building although at one time used at Low Houses. Tiered pews, boarded dado and walls are of 1860, as are the ceiling cornice and 4 fret-carved round wood ventilation panels. Large cast iron free-standing stove "The Romesse.", by Smith and Wellstood Limited, Columbian Stove Works, Bonnybridge, Scotland. C19 coloured glass in top lights of windows. The 1860 enlargement seems to have consisted of

raising the eaves and installing the tiered pews rather than an increase in area. John Wesley preached here.

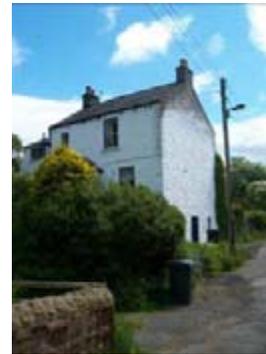
7 The School House

The School House is painted white to the rear and sides, the highest section of the south side and the front elevation being unpainted. The front elevation, unusually for Newbiggin, is of regularly coursed squared sandstone. The façade is symmetrical, with a central door set between two pairs of four-pane sash windows. The frames and sills are painted, and lintels unpainted. There is a small single storey extension to the north, with another door to the front elevation. In contrast with the fine masonry of the front elevation, rear and side elevation are of roughly coursed random rubble. The pattern of the rear elevation is less regular than the front, with a door set within a stone porch and windows set at different levels. A plain door in the south gable, with adjacent window, provides access to a level

beneath the ground floor. The roof is Welsh slate, with stone chimneys to both gables.

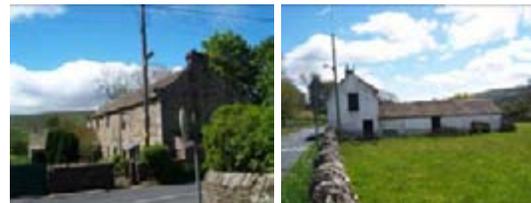
Riverside and Road Side

Several buildings cluster together on the main B6277 at the junction with the road up to the chapel. To the south side of the road are the village hall, Rose Cottage, the Hearse House and reading room and Road Side. Rose Cottage is a substantial seven-bay property set with its north gable to the road. It is of very roughly coursed sandstone rubble with large quoins. The roof is of graded stone slates, with a catslide extending to ground floor level to the rear. The gables have stone copings and kneelers. The roof has stone ridge-stones and gable copings, with a chimney in the north

To the east of the former Hearse House is Road Side, a substantial two storey house with its rear (north) elevation to the road. The rear elevation and east gable have four-pane sash windows set between plain stone lintels and sills. The upper floor of the west gable has a door, and suggesting that this once functioned as a barn; there is a blocked window in the north elevation. The entire building is whitewashed with painted sills and lintels in the characteristic Raby Estate style. The roof is stone slates, topped by two stone chimneys. A long single-storey extension extends from the west end of the south elevation. This has a stone slate roof which appears to be in poor condition.

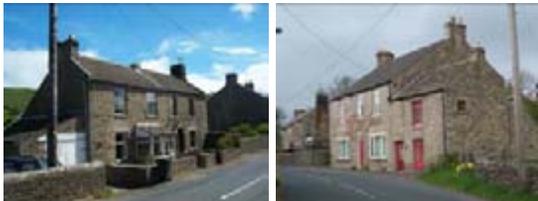
*The Old Post Office,
Post Office Cottage*

On the north side of the B6277 are Bridge End and the Old Post Office/Post Office Cottage. Bridge End consists of two semi-detached houses of neatly coursed squared sandstone with quoins. The roof is of corrugated tiles, the pitch of the roof being slightly steeper than that of the gables, confirming that this is not the original roof. The roof extends as a catslide

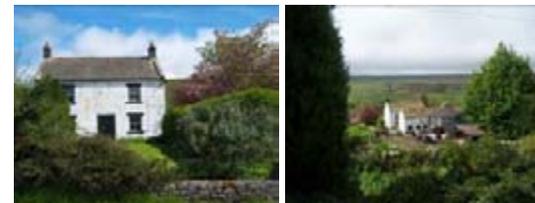
13 Newbiggin House

Newbiggin House, once an inn and during the mid-19th century the local lead mining agent's house, is set back from the north side of the B6277. It is a traditional three-bay house of

narrowly coursed sandstone, painted white, with a stone slate roof. It has stone chimneys to each gable, stone gable copings and ridge tiles. The central half-glazed door is set within plain stone jambs and lintels. The four-pane sash windows are set between plain lintels and slightly protruding sills. Window lintels, sills and frames, and door surrounds, are painted. The house has large extensions and outbuildings to the rear.

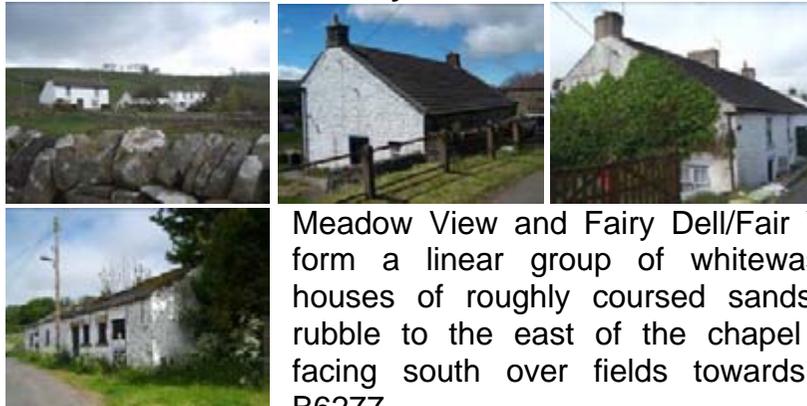
14 Meadow View and Fairy Dell/Fair View

Meadow View and Fairy Dell/Fair View form a linear group of whitewashed houses of roughly coursed sandstone rubble to the east of the chapel and facing south over fields towards the B6277.

Meadow View is a detached house with a roof of concrete slates with ridge stones and gable copings, and a stone chimney to each gable. Its asymmetrical front elevation has a central door set within a plain stone surround between two large windows of modern form, with traditional sashes to the first floor above each. Door jambs, lintels and sills are painted. The masonry of the gables suggests that the house was originally narrower, with a single storey rear extension added and the catslide rear roof extended to cover this.

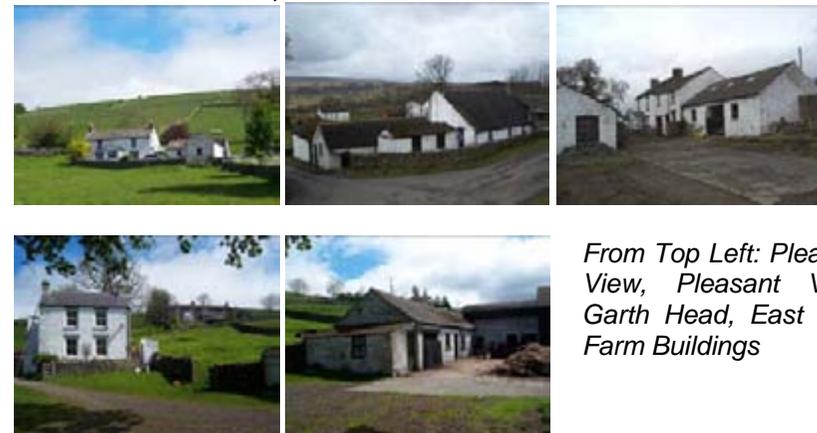
From Top Left: Pleasant View, Pleasant View, Garth Head, East End, Farm Buildings

Pleasant View, Garth Head and East End form a group of whitewashed houses with outbuildings in the eastern half of the village facing south over fields towards the main road. Pleasant View is a house with a cluster of several

Garth Head is a linear range of house, barn and byre, with a further outbuilding to the south. The house has a central door set within a stone porch, with a pair of traditional four-pane sashes to either side, set between painted lintels and sills. An extension to the rear is of brick, and a flat roof over this seems to have replaced an earlier catslide roof to the rear. The roof is of stone slabs, with a stone chimney over each gable. The barn to the east is of similar form, with a double vehicle door and a further single door to the front elevation. The byre, which extends the range to the east, has a roof of corrugated tiles and a large double gate with a single window to either side.

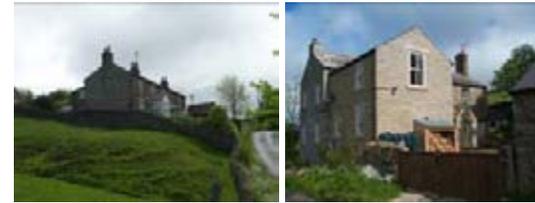
16 Hill Top and Corner Cottage

Hill Top and Corner Cottage are located to the north side of Miry Lane, facing south. Hill Top consists of 3 terraced

cottages of roughly coursed sandstone rubble, with stone slate roof, each property having a stone chimney. Variations in masonry demonstrate that the houses are clearly of more than one phase. Entrances are set within substantial porches so that the original ground floor facade is largely hidden behind glass and white-painted frames. The westernmost property has modern sashes of traditional form; other windows are less traditional.

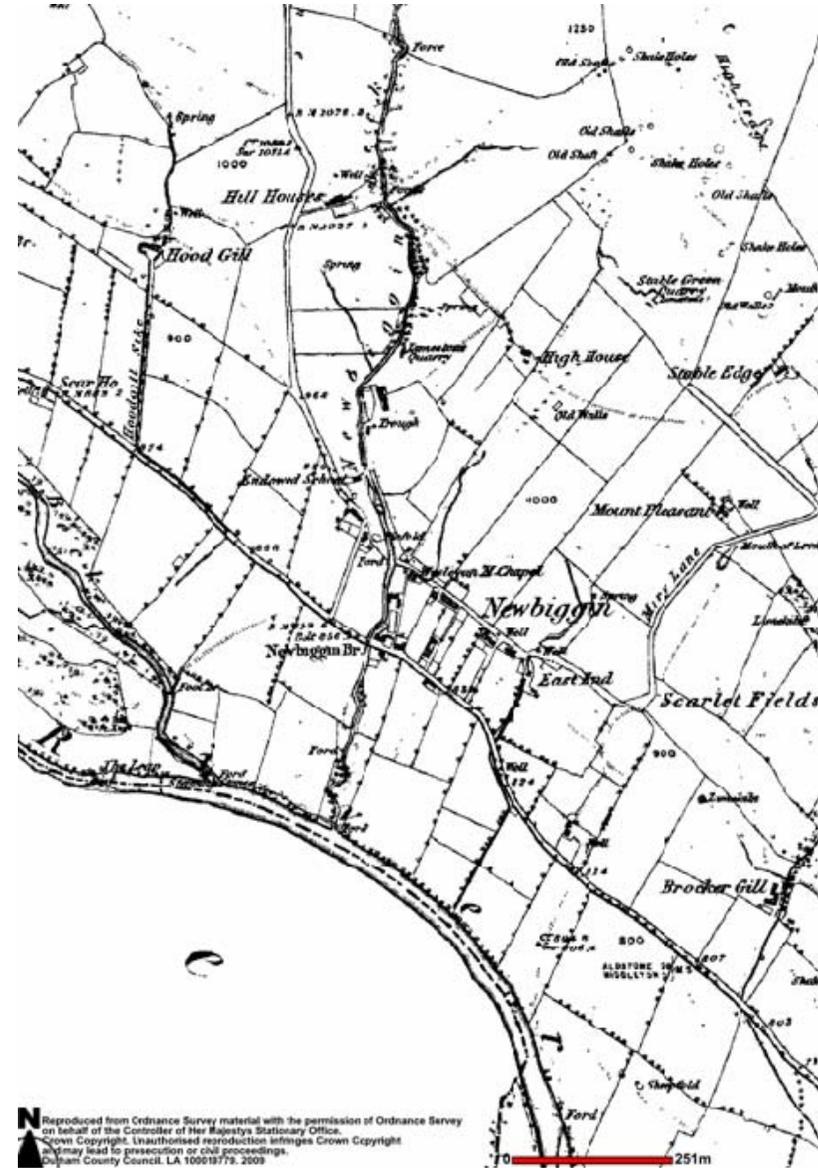
OS 1st Edition map of the Newbiggin area, c1856

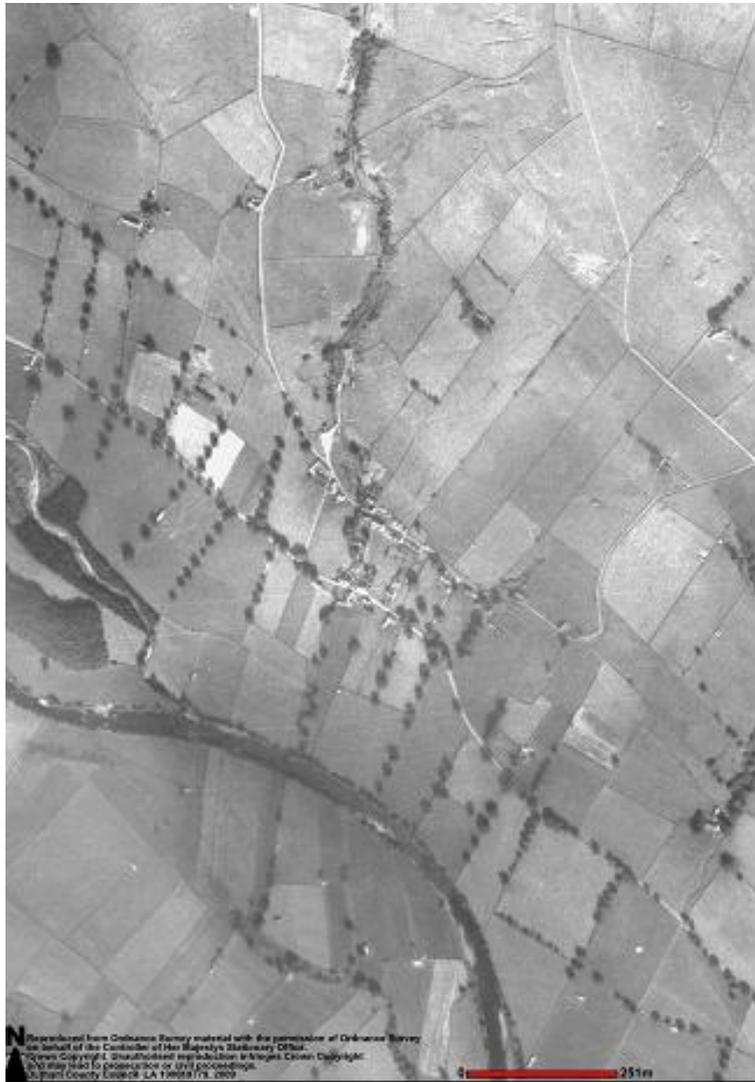
The lack of change in the Newbiggin landscape during the twentieth century illustrated by air photographs taken in the 1940s (left) and 2004 (above)
