New Excavations at Binchester: Results of the 2014 Season

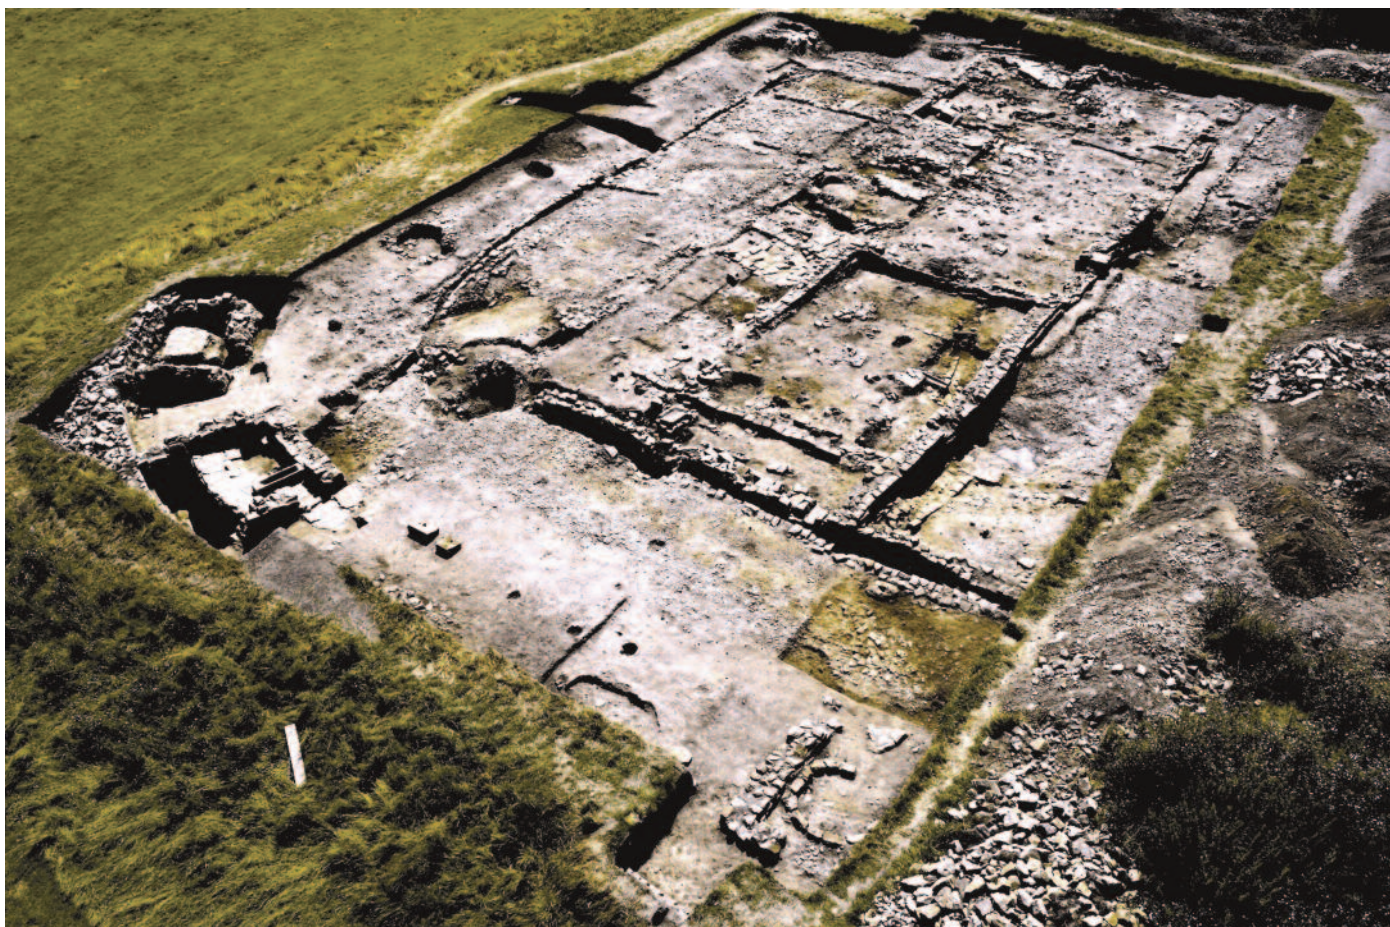
2. Aerial view of Trench 1 looking west.

Work continued this year on the cavalry barrack in the east corner of the fort (1 & 2). Numerous post-holes were uncovered belonging to successive timber partition walls within the stone barrack along with further examples of the slots or troughs that served to drain or collect the horses' urine. The gable wall of the building next to the intervallum had clearly been rebuilt on at least one occasion. Towards the end of the season a drainage channel was found below the floor of the adjacent officer's accommodation running at an angle to the general alignment of the building and passing beneath its north wall (6). Two infant burials were found a little further to the west one either side of the north wall.

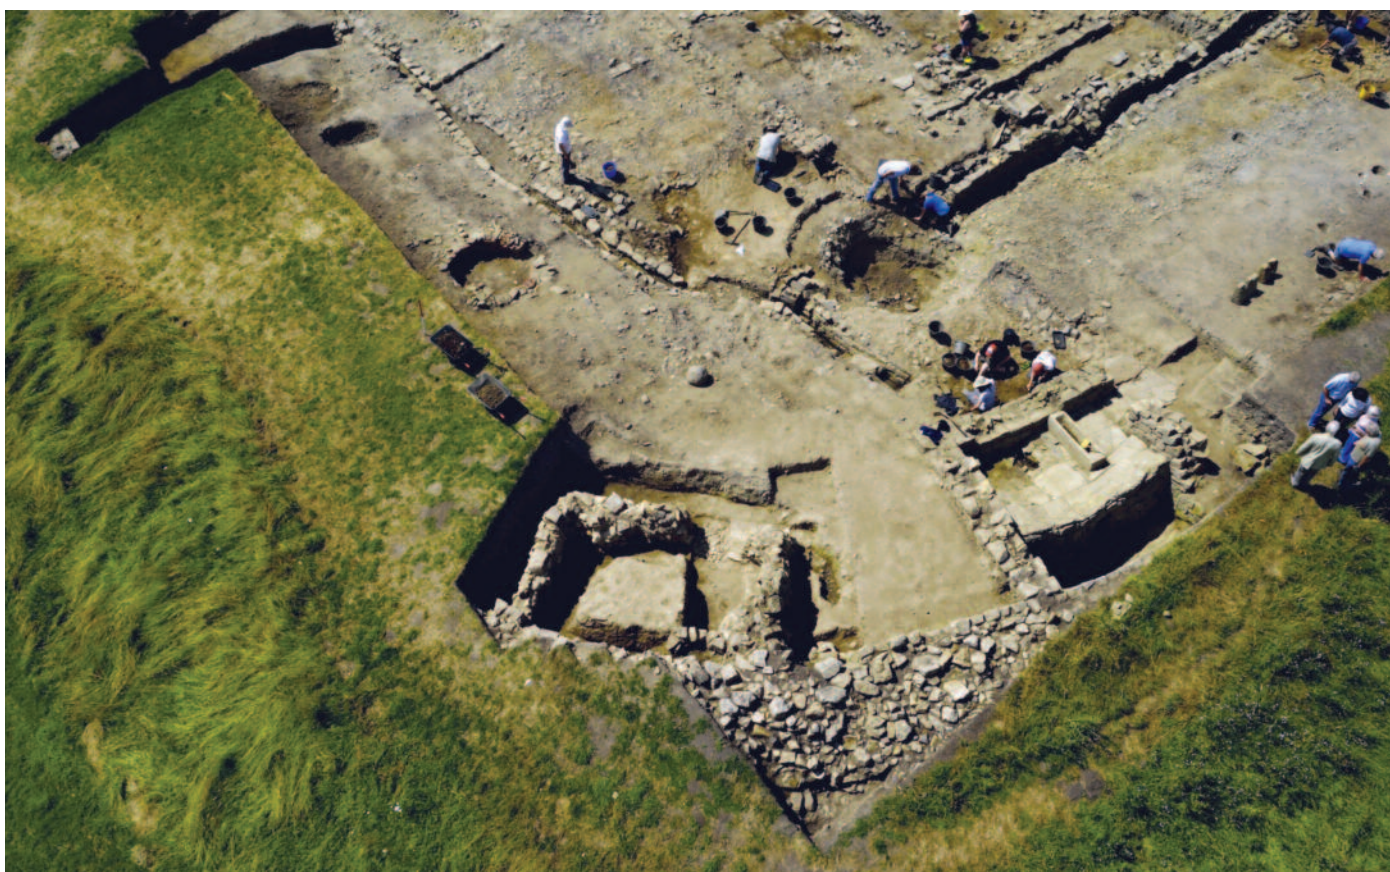
3. Aerial view of Trench 1 showing east corner of fort showing fort wall, angle-tower and adjacent latrine building.

At the east corner of the defences the excavation area was extended to encompass the entirety of the angle-tower including the fort wall (3). The side and back walls were found to have been severely affected by stone-robbing with the inner and outer facing-stones having been removed from all but the lowest course. Another extension to the area of excavation was made on the south-east side to define the precise position of the fort wall on this side. The space between the back of the fort wall and the intervallum road is wider here than on the north-east side. This is because the defences on this side belong in origin to the larger primary fort whereas the latter are exclusively Antonine. The interior face only of the fort wall was exposed and was found to be of different construction and rather cruder in form

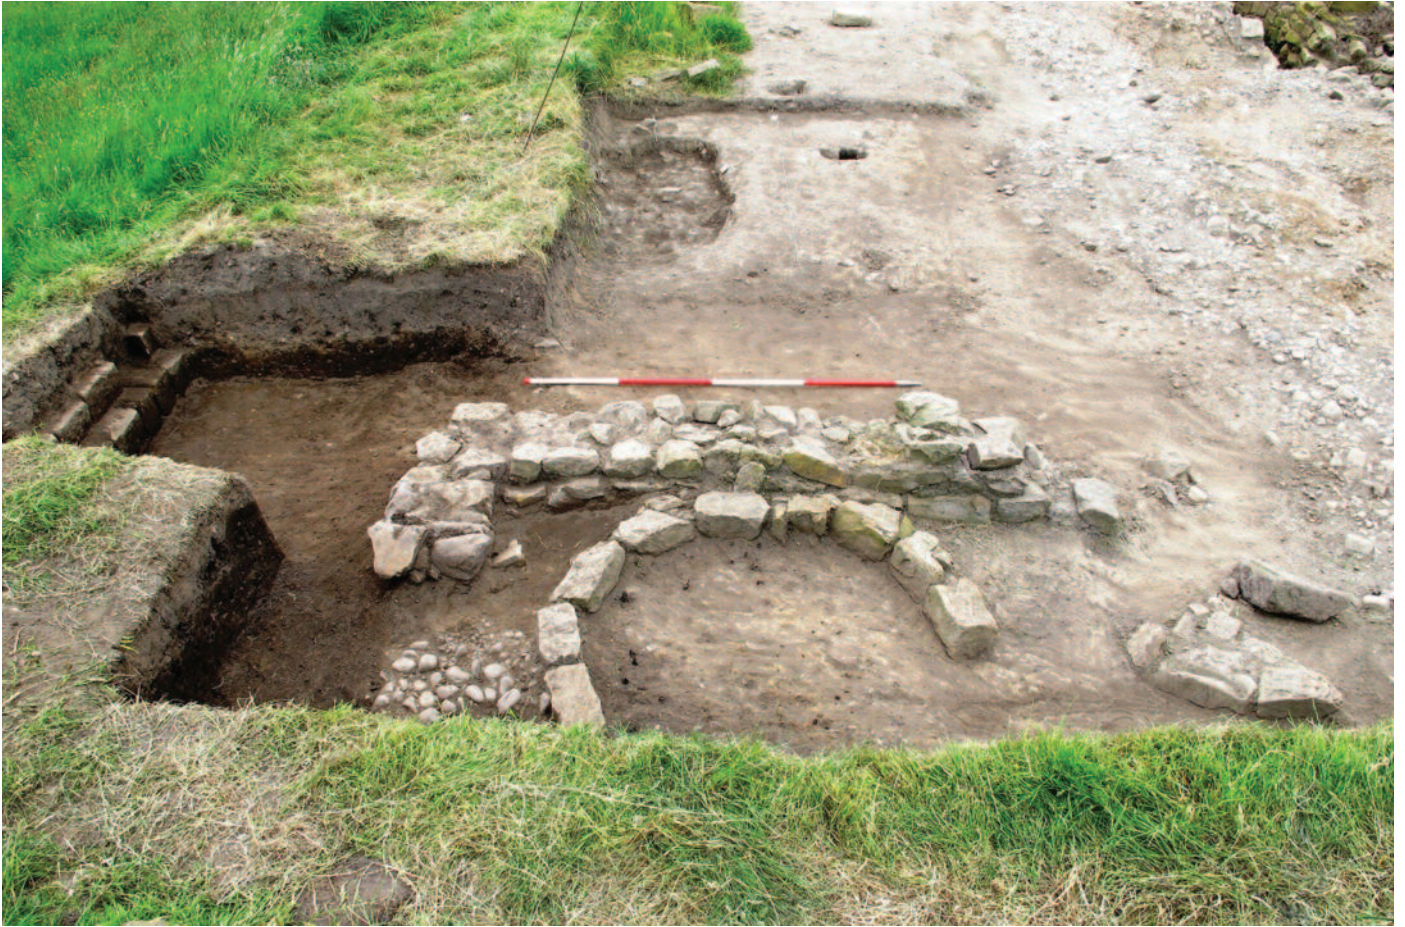
4. Trench 1 showing free-standing enclosed oven structure at rear of north-east fort wall.

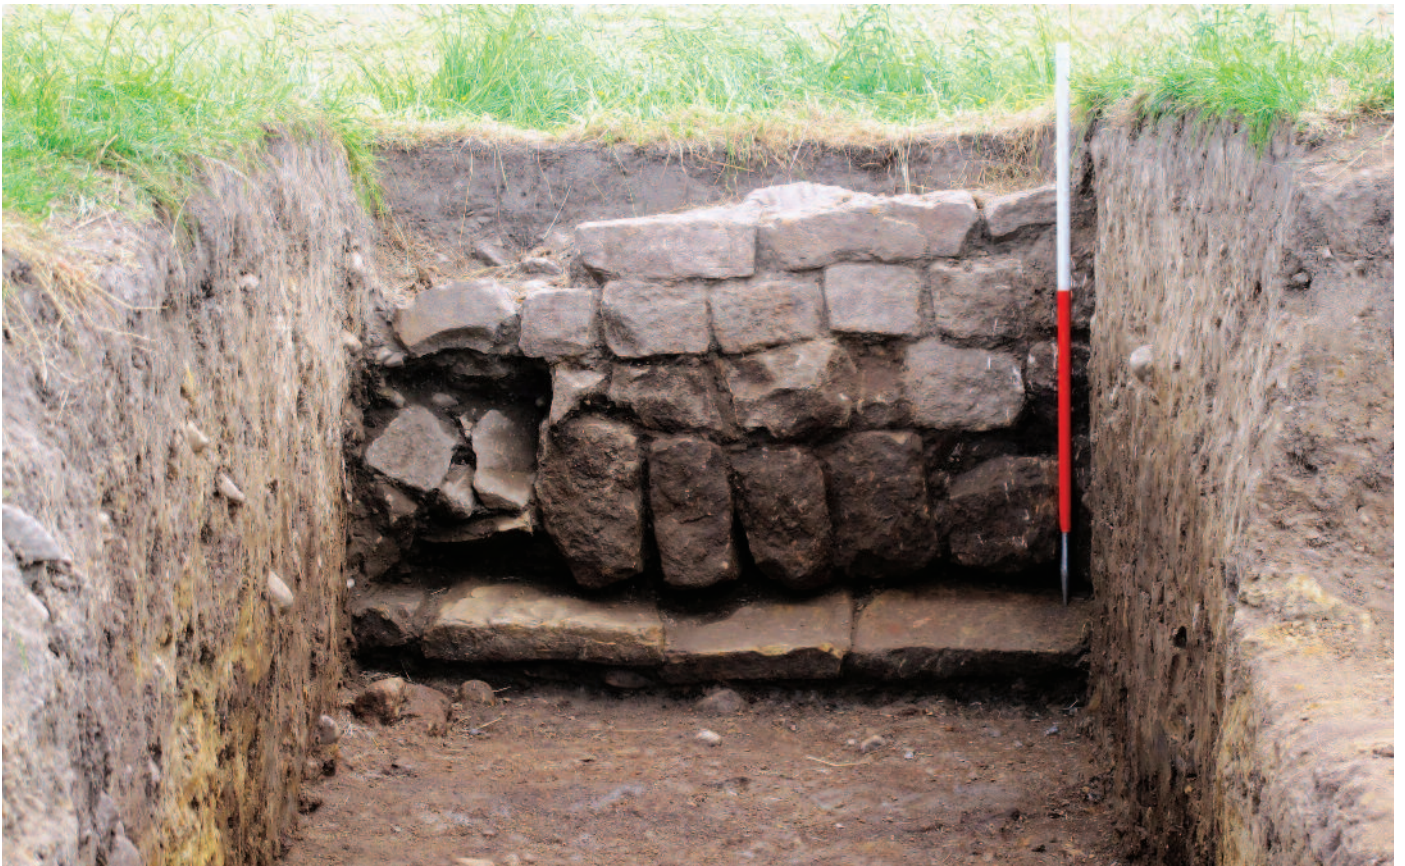
5. Trench 1 rear face of fort wall on south-east defences.

than the neatly dressed masonry of its counterpart on the north-east side (5). This could be explained by it being a later repair. Then again, it could be a wall added to the front of the rampart belonging to the primary fort before its abandonment in the Hadrianic period and then incorporated in the later wall.

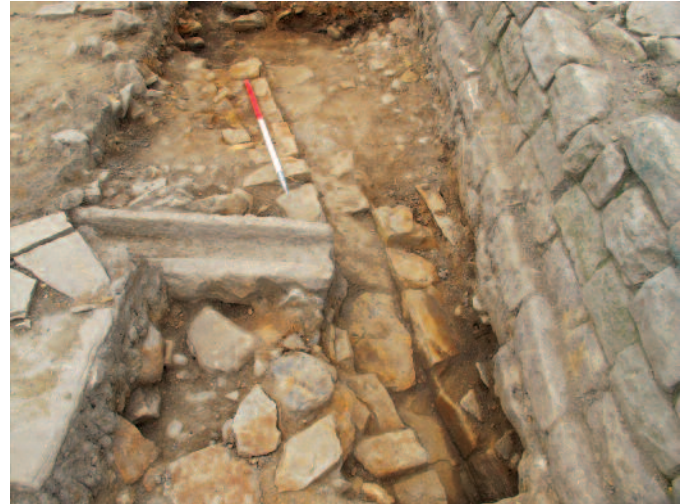
6. Trench 1, drain passing beneath north wall of barrack.

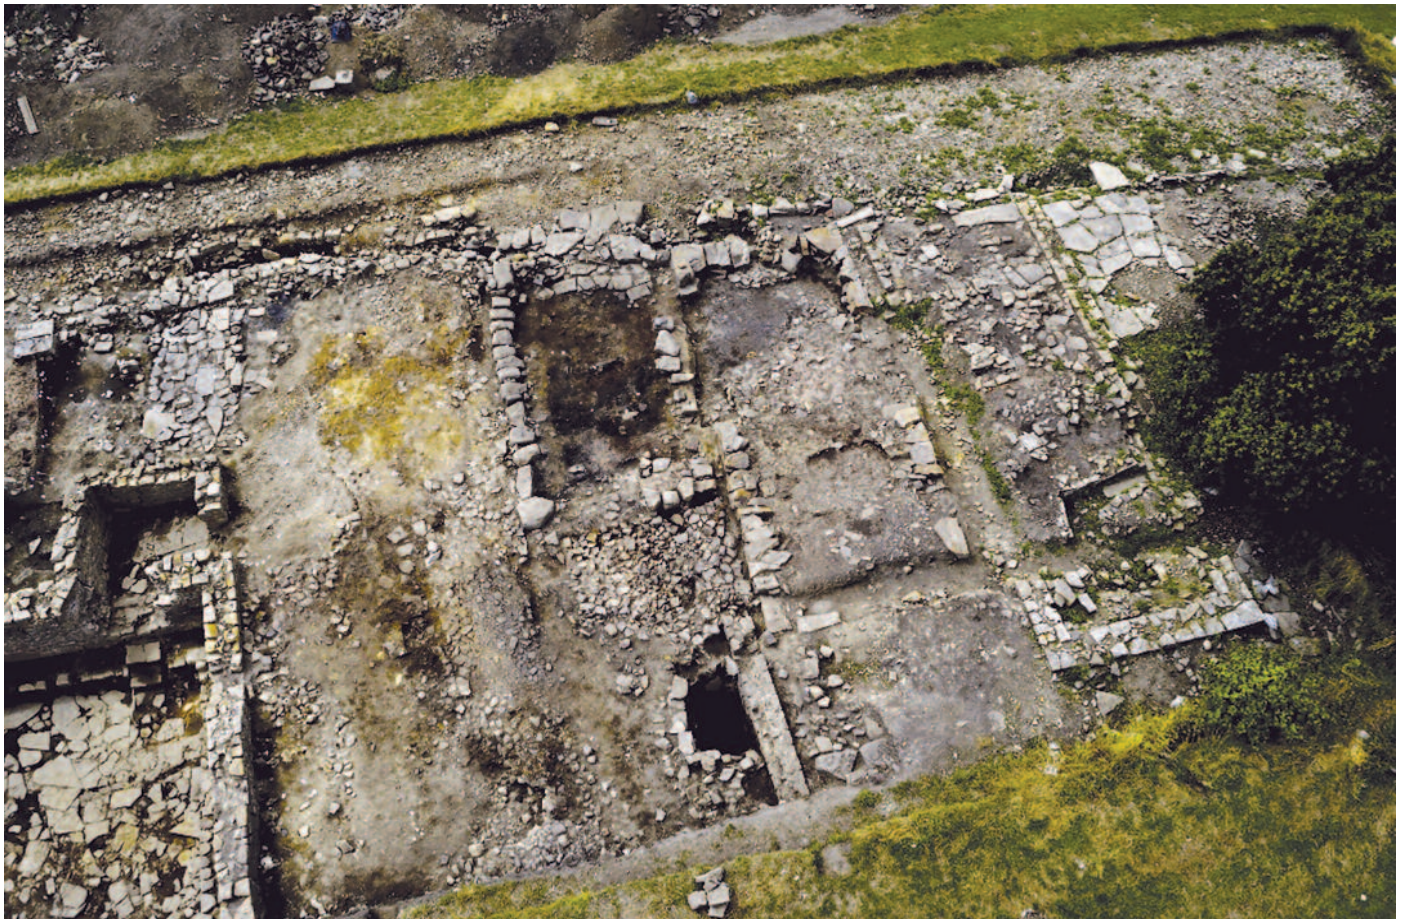
7. Aerial view of Trench 2 showing third strip-building revealed this year.

In the trench outside the fort excavation revealed a third 'strip-building' immediately south of the two uncovered in previous seasons (7). This one is slightly smaller overall than its neighbours and is even cruder in construction. The wall footings consisted of large blocks or boulders which seem likely to have acted as the base for a timber-framed superstructure. This late structure partly overlies the wall of an earlier building. Excavation of a late pit adjacent to this wall revealed its southern face to be constructed of neatly-dressed blocks in a style very reminiscent of the north-east fort wall (8). This could conceivably have been the perimeter wall of an open-air exercise yard

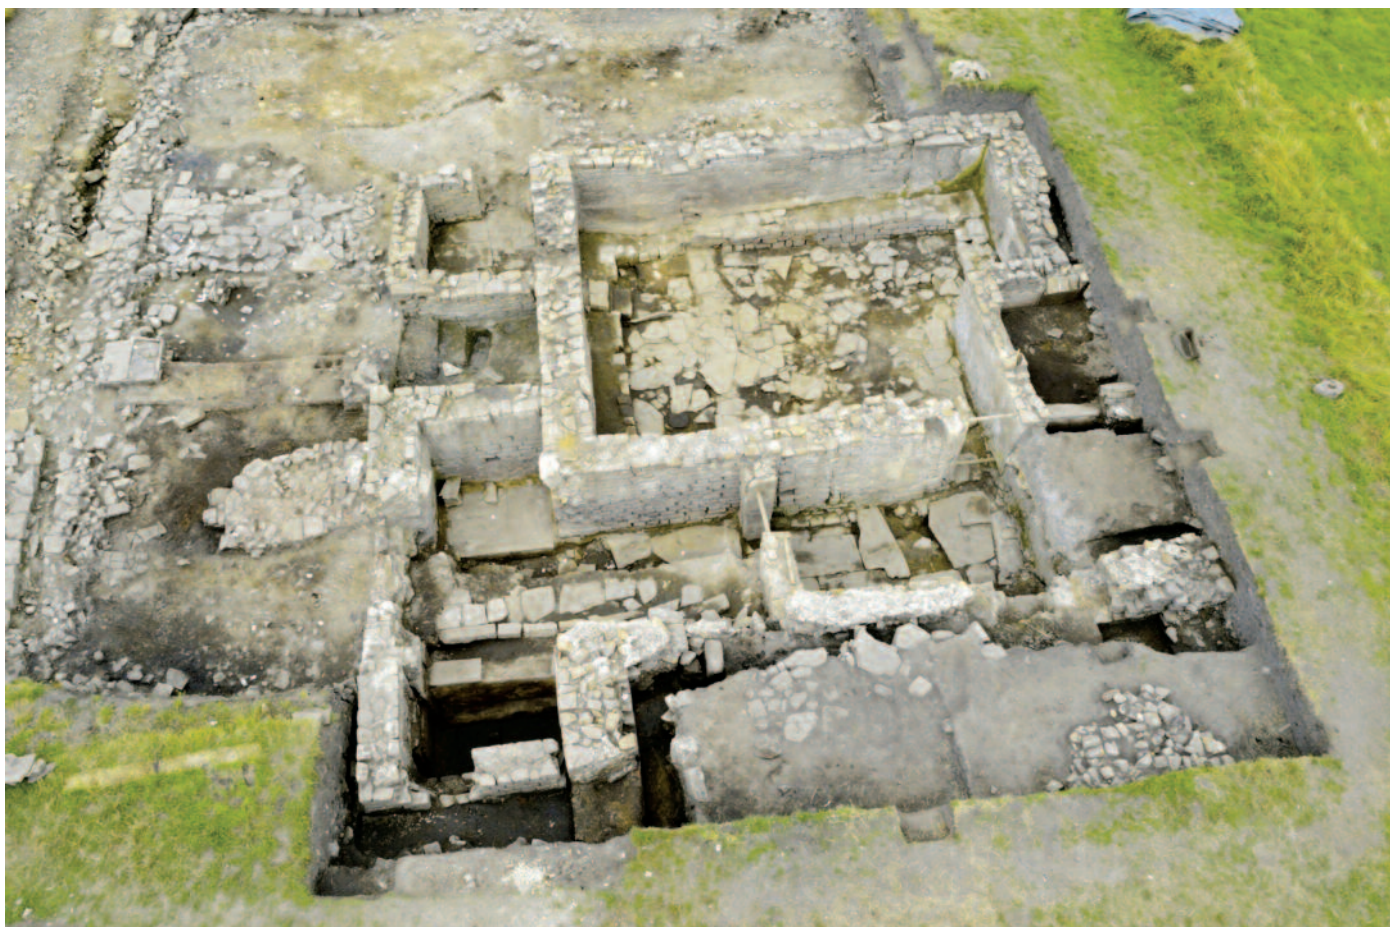
8. Trench 2 Aerial view of bath-building.

second month as in previous years. As work has progressed this building's marvellous state of preservation has become ever more apparent. Only a small portion of this structure lies within the current excavation (9). Two chambers belonging to the original building have been revealed; a large room measuring 10 m by 6 m internally and most probably the changing-room or apodyterium and, running along the south side of this a narrow corridor-like room. Another chamber to the south has been partially exposed and this was probably the first of three such chambers forming the conventional linear layout of frigidarium, tepidarium and caldarium with the principal furnace/s beyond the last of these along with the water reservoir (*castellum aquae*). Hooppell excavated a circular room originally equipped with a hypocaust just a few metres east of the boundary of the new excavation and directly in line with the corridor. Rooms of this shape functioned as dry heat sweating chambers (*laconica*) contrasting with the steamy

As described in last year's magazine the most striking aspect of this building is its remarkable state of preservation: walls still standing 2.1 m or more above Roman floor level and including features such as doorways, window embrasures and the haunches of arches and vaulting-ribs along with extensive in-situ areas of painted wall-plaster.

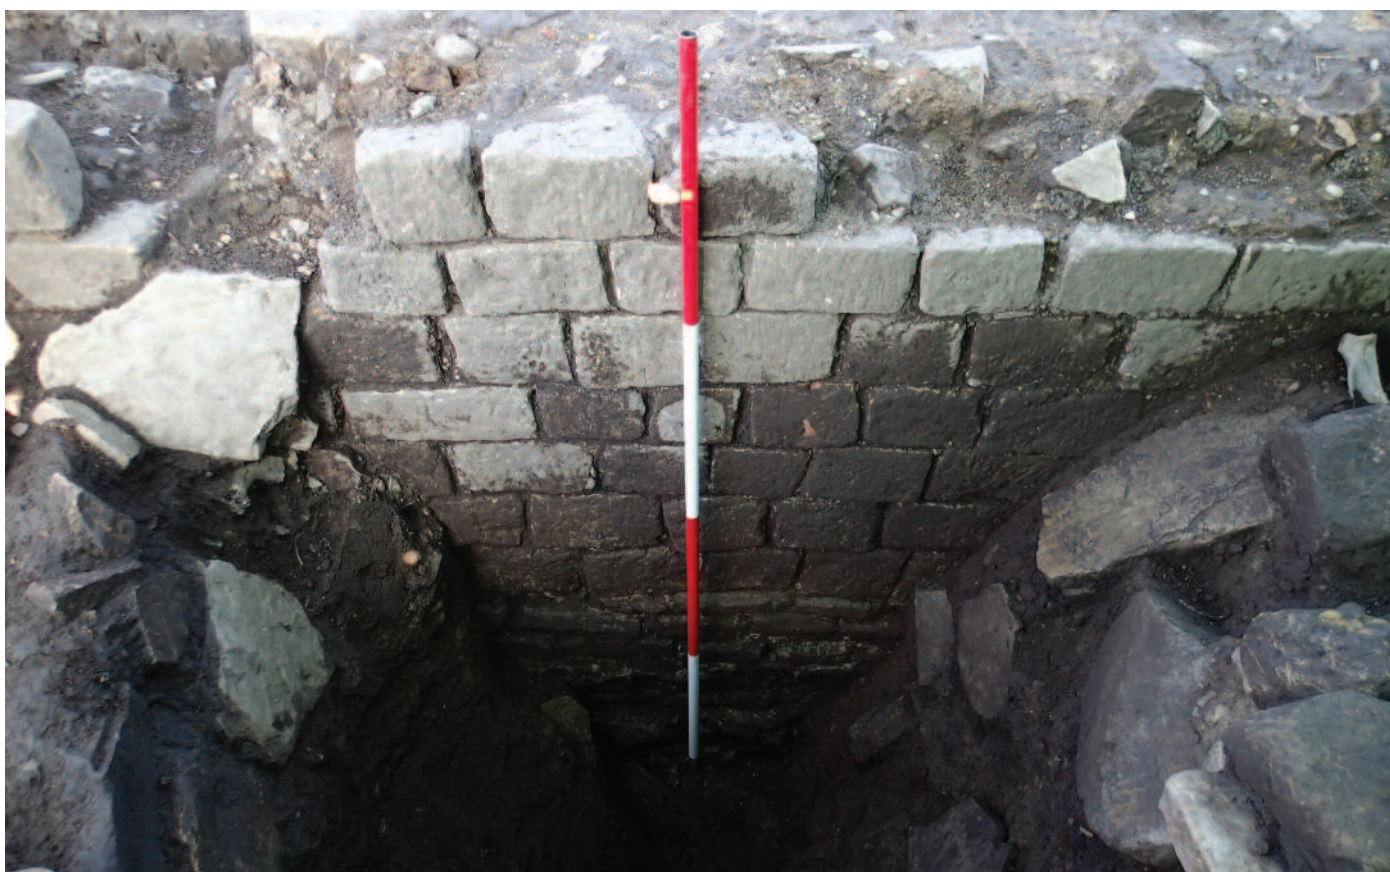
9. Trench 2 south face of earlier wall beneath late strip-building (back wall of palaestra colonnade?).

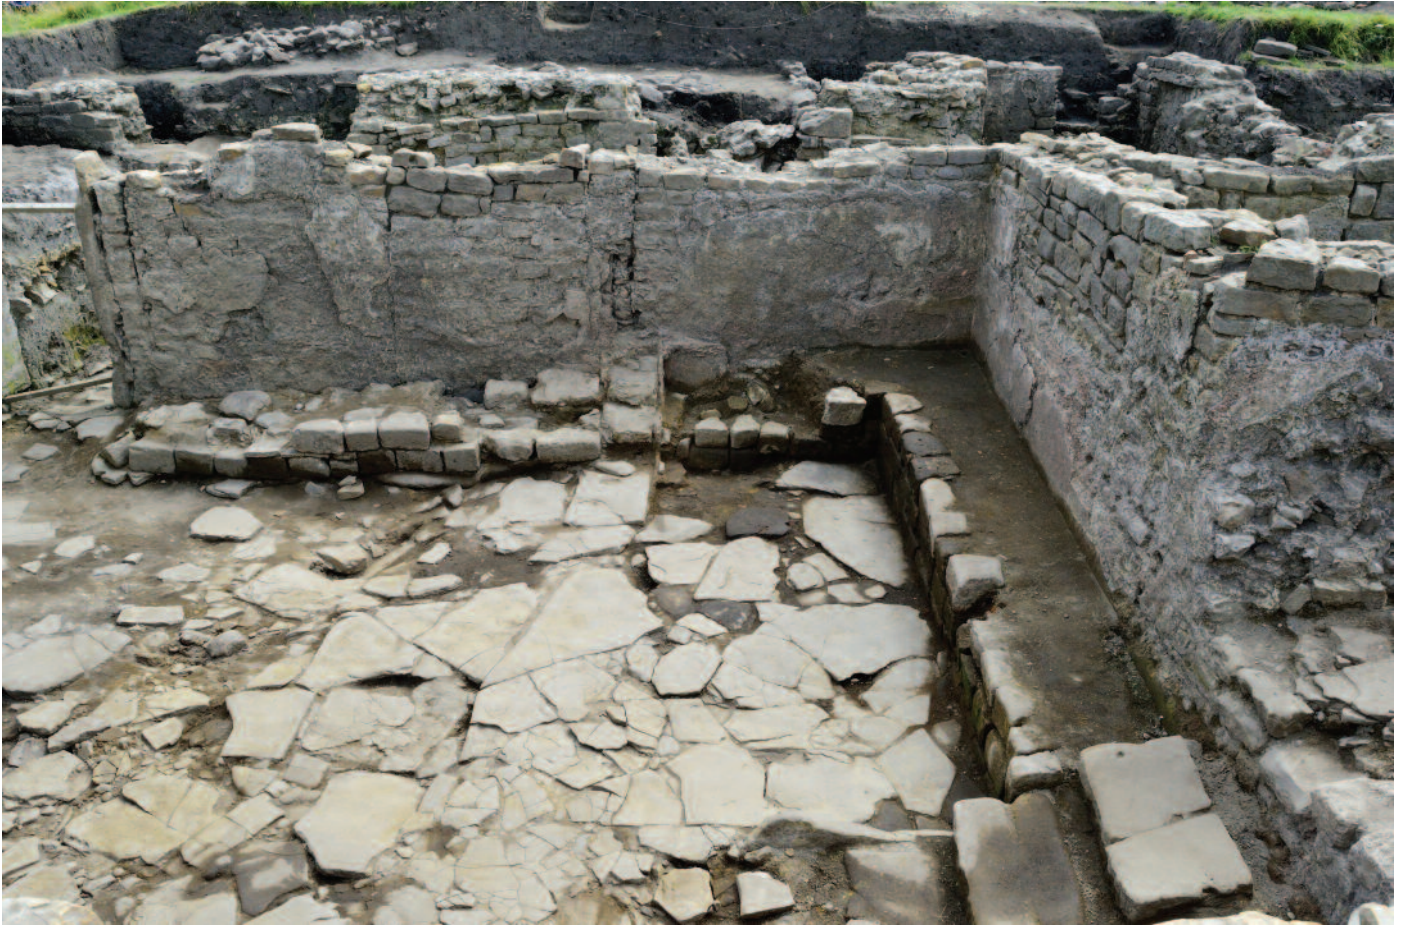
10. Bath-building, south wall of apodyterium.

Access into the apodyterium, and thus the building in general, appears originally to have been via a doorway in its north wall from the area which, as just mentioned, may have been an exercise yard enclosed by a colonnade (*palaestra*). The original doorway into the corridor was positioned centrally in the south wall of the apodyterium (10). The west wall of the room, facing out towards Dere Street, was pierced by

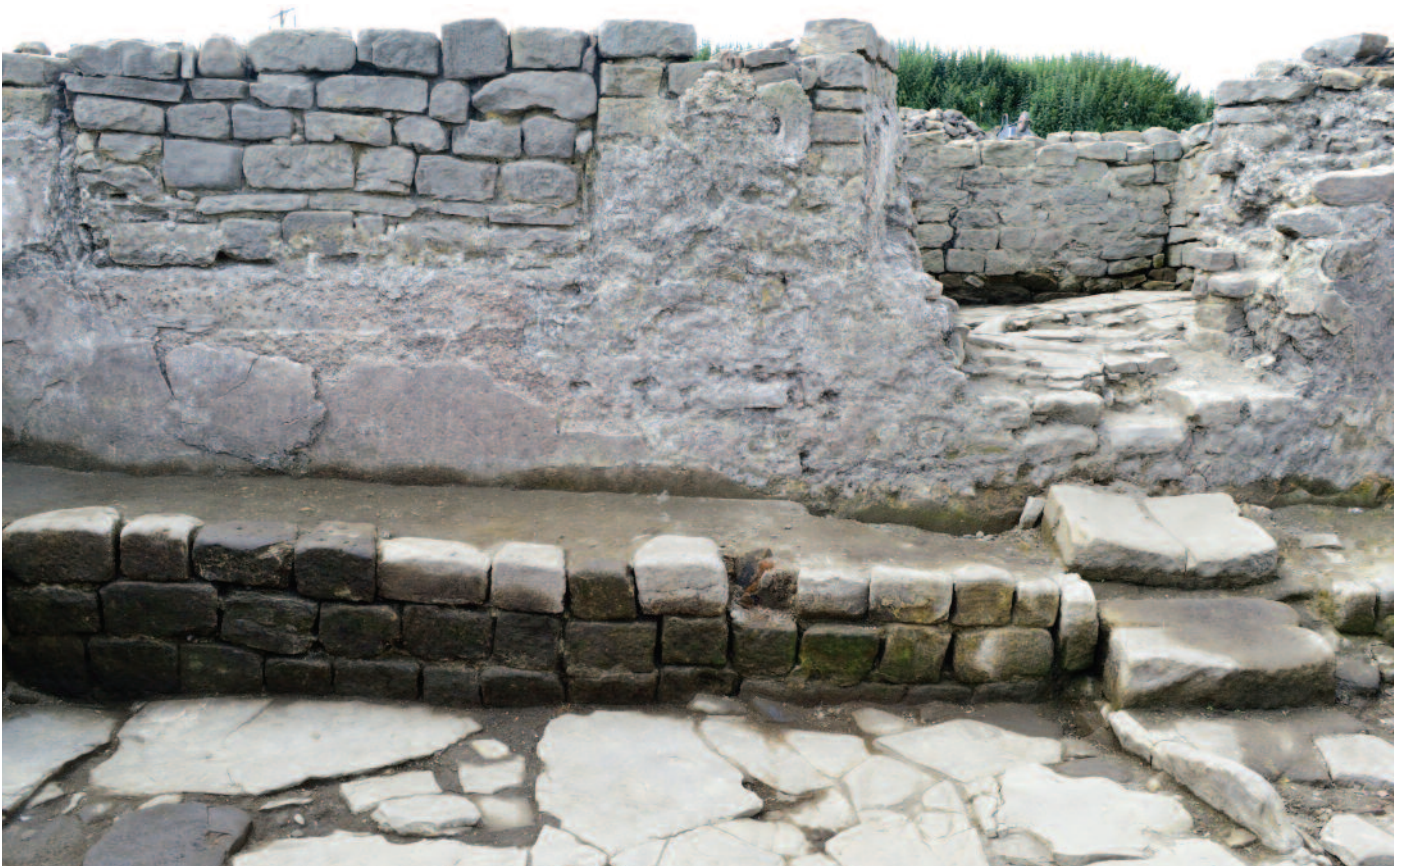
11. Bath-building, west wall of apodyterium showing blocked-up window embrasure to left and cut-down window embrasure with inserted steps to right.

two large and splayed window embrasures. These measured 1.70 m wide internally and 1.30 m externally and were spaced 0.90 m apart. The lower edge of the sloping window sills lay 1.30 m above the floor (11). The fact that these large windows faced out onto the main street would not have encouraged voyeurs or embarrassed the bathers because the windows would have been glazed with small panes of opaque glass set in an iron frame.

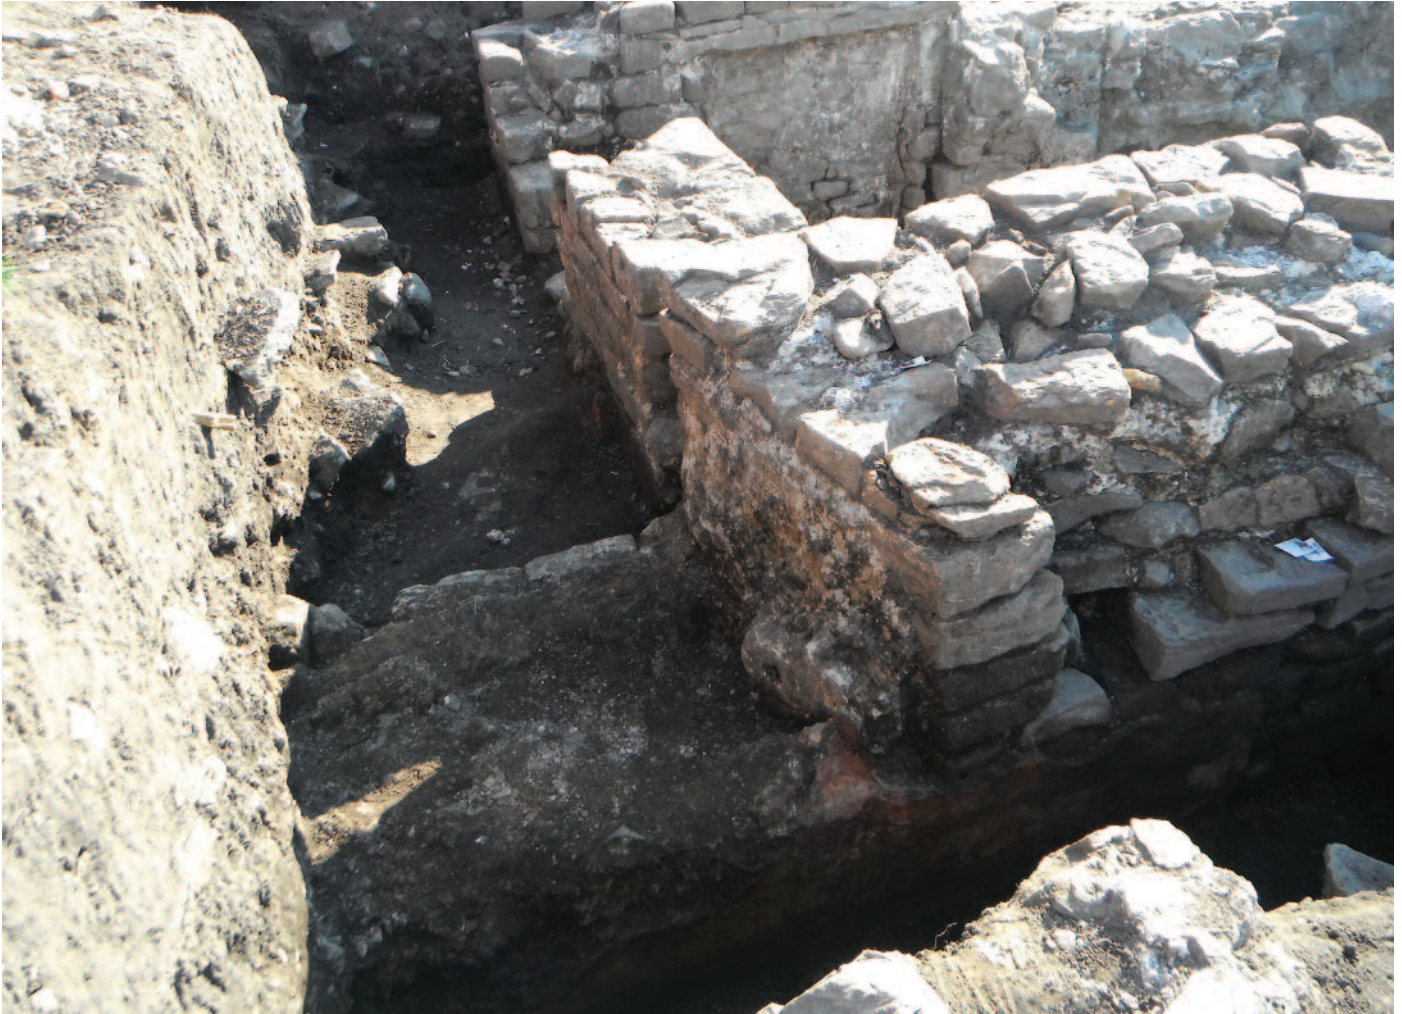
12. Bath-building, west wall of room south of corridor showing window embrasure with painted plaster in situ.

The original west wall of the corridor had been removed during a later phase but would probably have incorporated a window like those in the apodyterium. A doorway near the west end gave access to the first of what is assumed to have been a suite of chambers lying to the south. Its west and east walls were continuation of those of the apodyterium and the chamber can be assumed to have been of similar dimensions. Only a small portion of this room has been excavated at the time of writing but it is clear that its painted wall-plaster is very well-preserved and also that its west wall incorporated at least one window

embrasure like those already described (12 & 13).

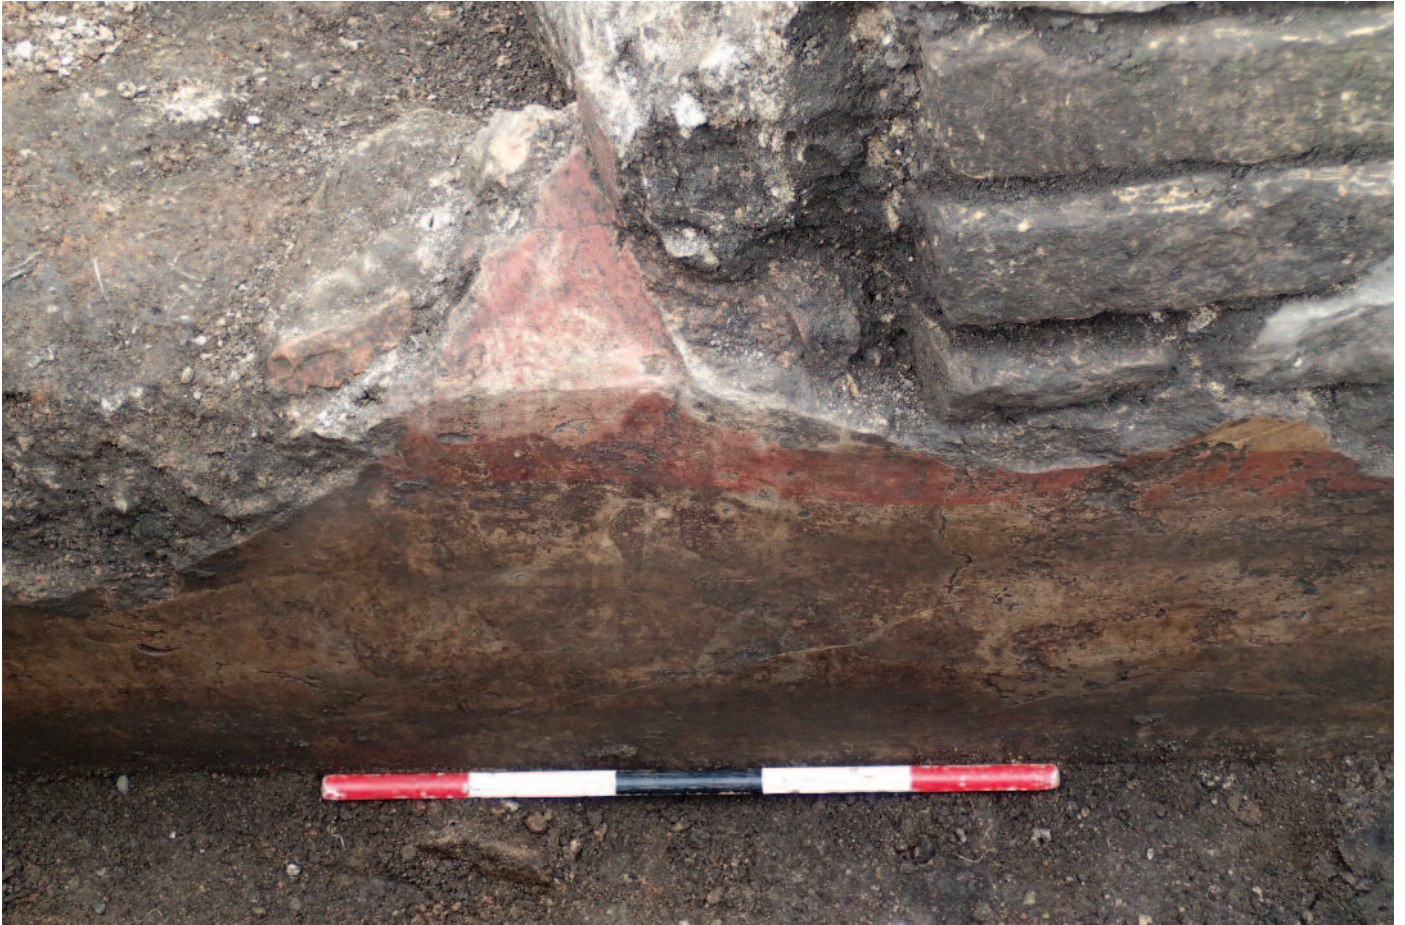
13. Bath-building, close-up of painted plaster shown in image 12.

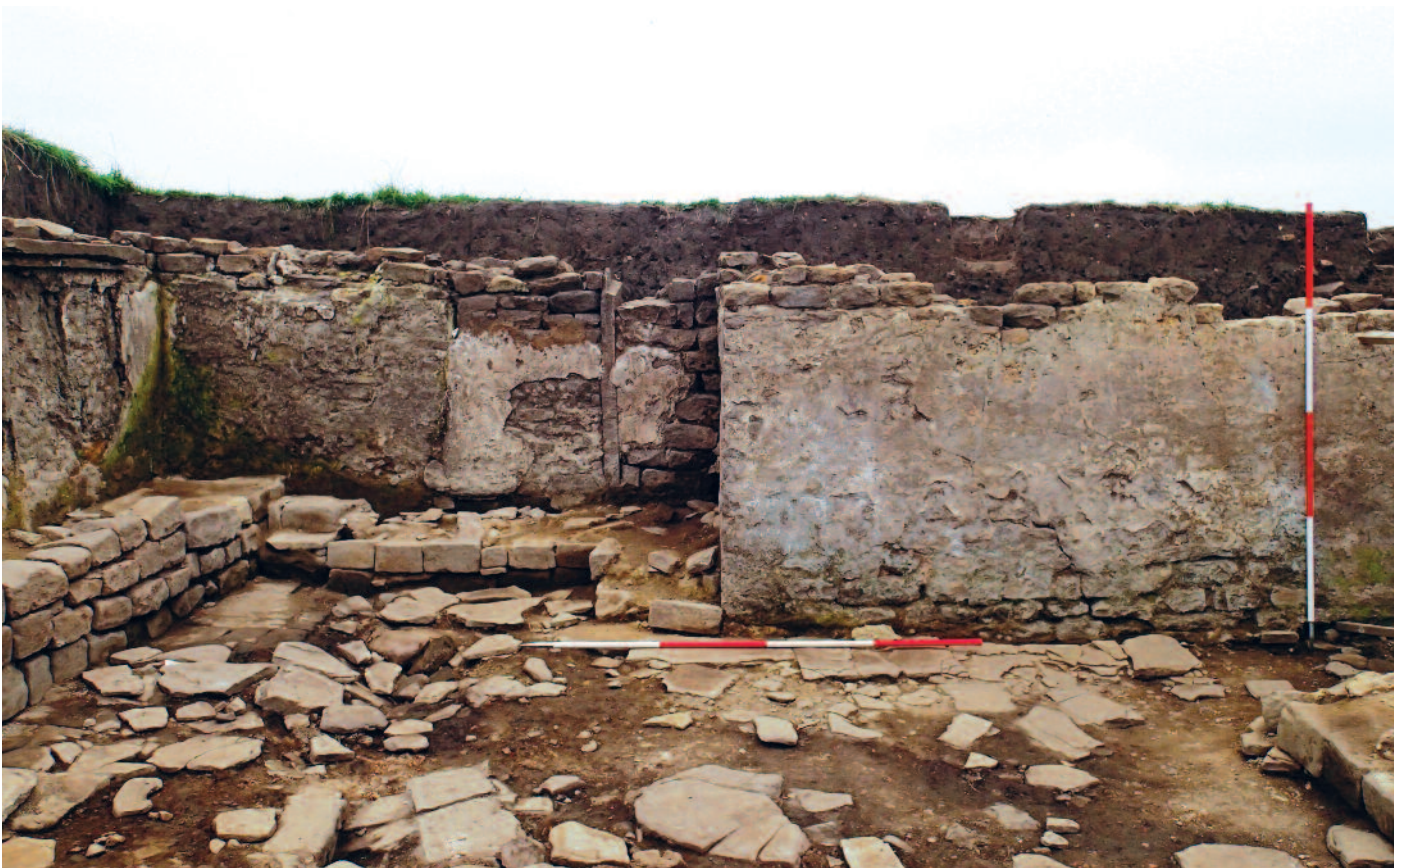
14. Bath-building, east wall of apodyterium showing blocked-up doorway and wall of intruding secondary chamber.

There are a number of modifications which judging from their structural interrelationship could have belonged to a single and major scheme of refurbishment. Most of the east wall of the changing-room was demolished to enable the construction of a new chamber which projected into the apodyterium by c. 1 m and forming a 2 m wide alcove in the north-east corner. The surviving stretch of the east wall of the apodyterium included a narrow doorway (14). This had been blocked-up and plastered over in a later phase of alteration. Whether this was part of the original design or inserted when the alterations currently being described were effected cannot be determined. The new chamber measured 3 m wide internally. Its walls were lined with a thick render of waterproof concrete and its floor was formed of the same material incorporating a narrow step or bench against the south wall (15 & 16). This had clearly functioned as a plunge-bath though whether hot (alveus) or cold (piscina) is unknown at present. Both haunches of a

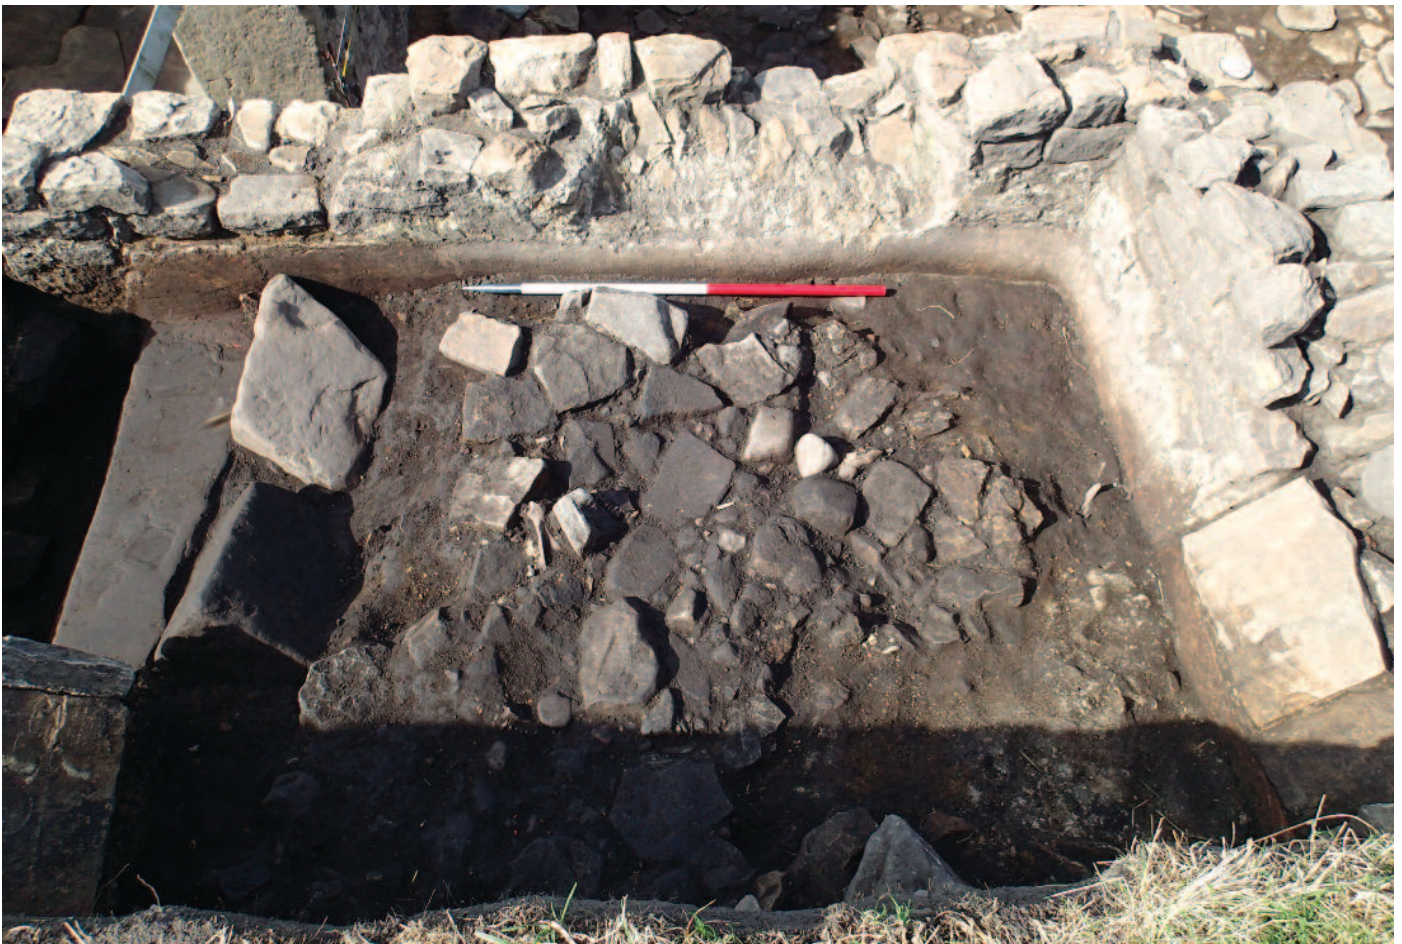
15. Bath-building, part of secondary chamber intruding into apodyterium at early stage of excavation.

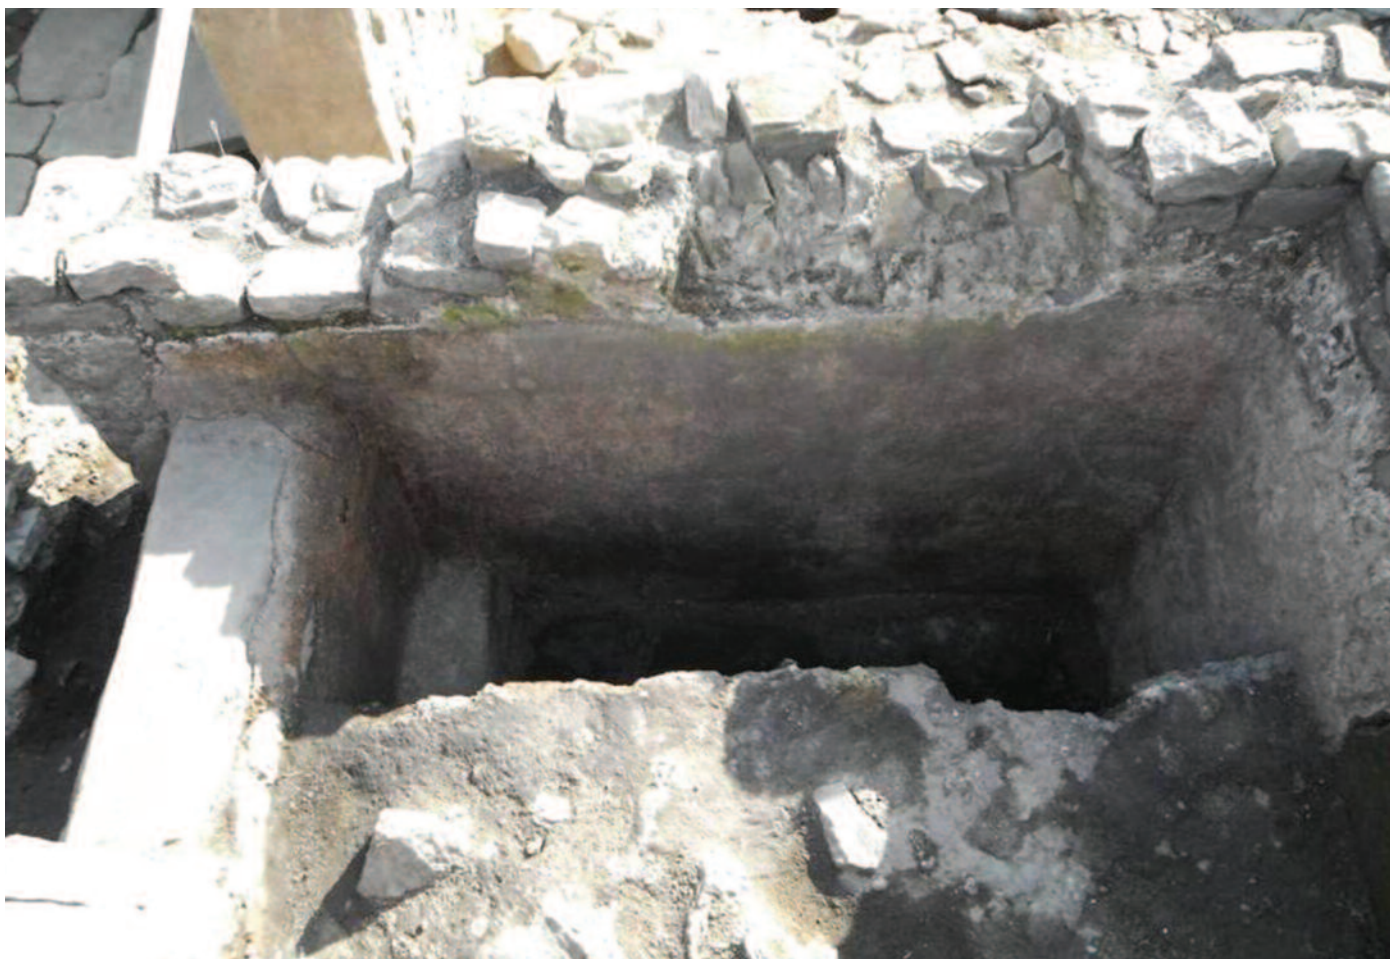
16. Chamber shown in image 15 with section excavated down to floor level.

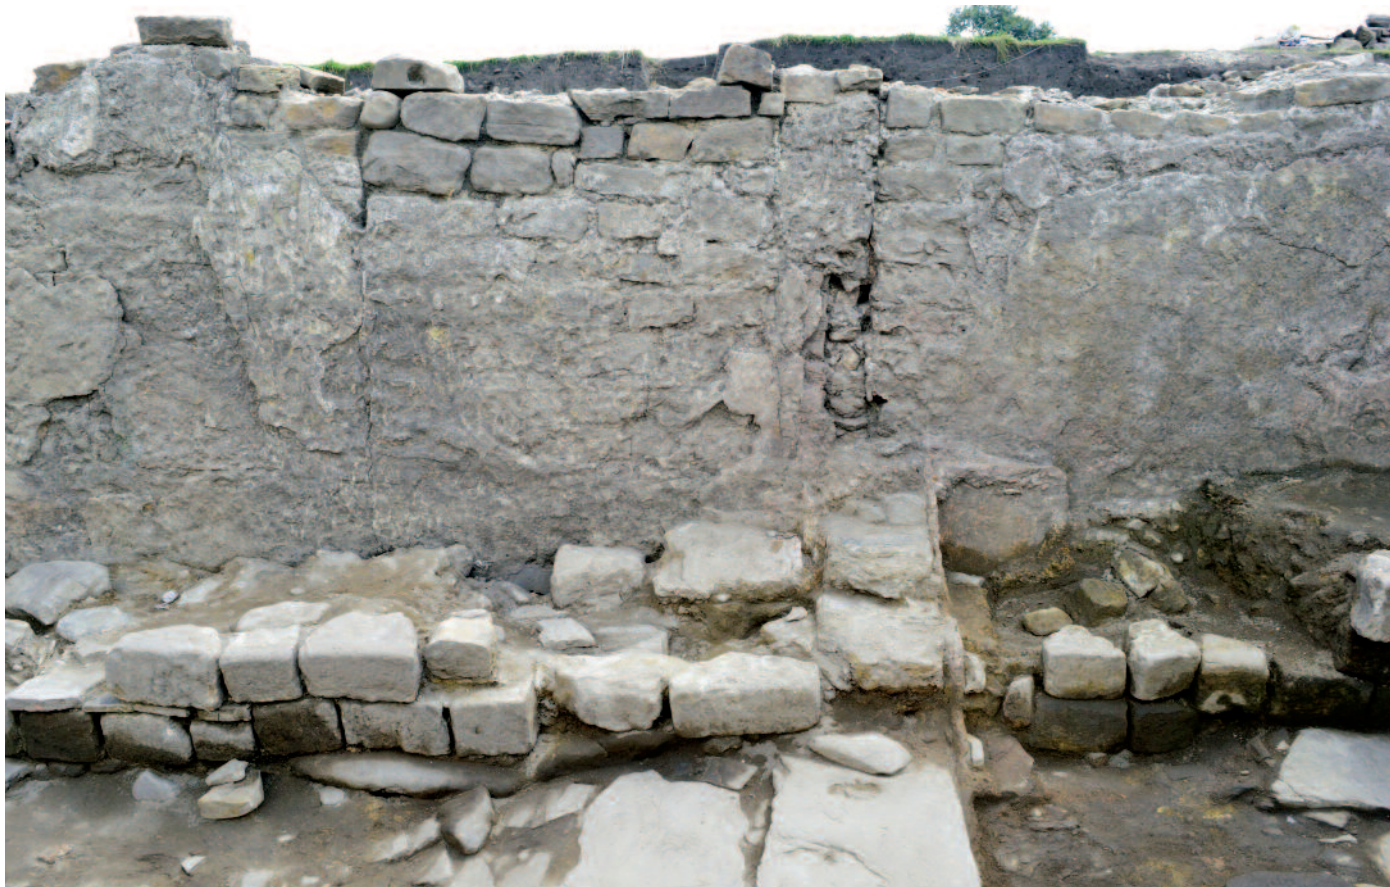
17. South wall of apodyterium showing blocked-up doorway with stub of retaining wall at front of inserted plunge-bath.

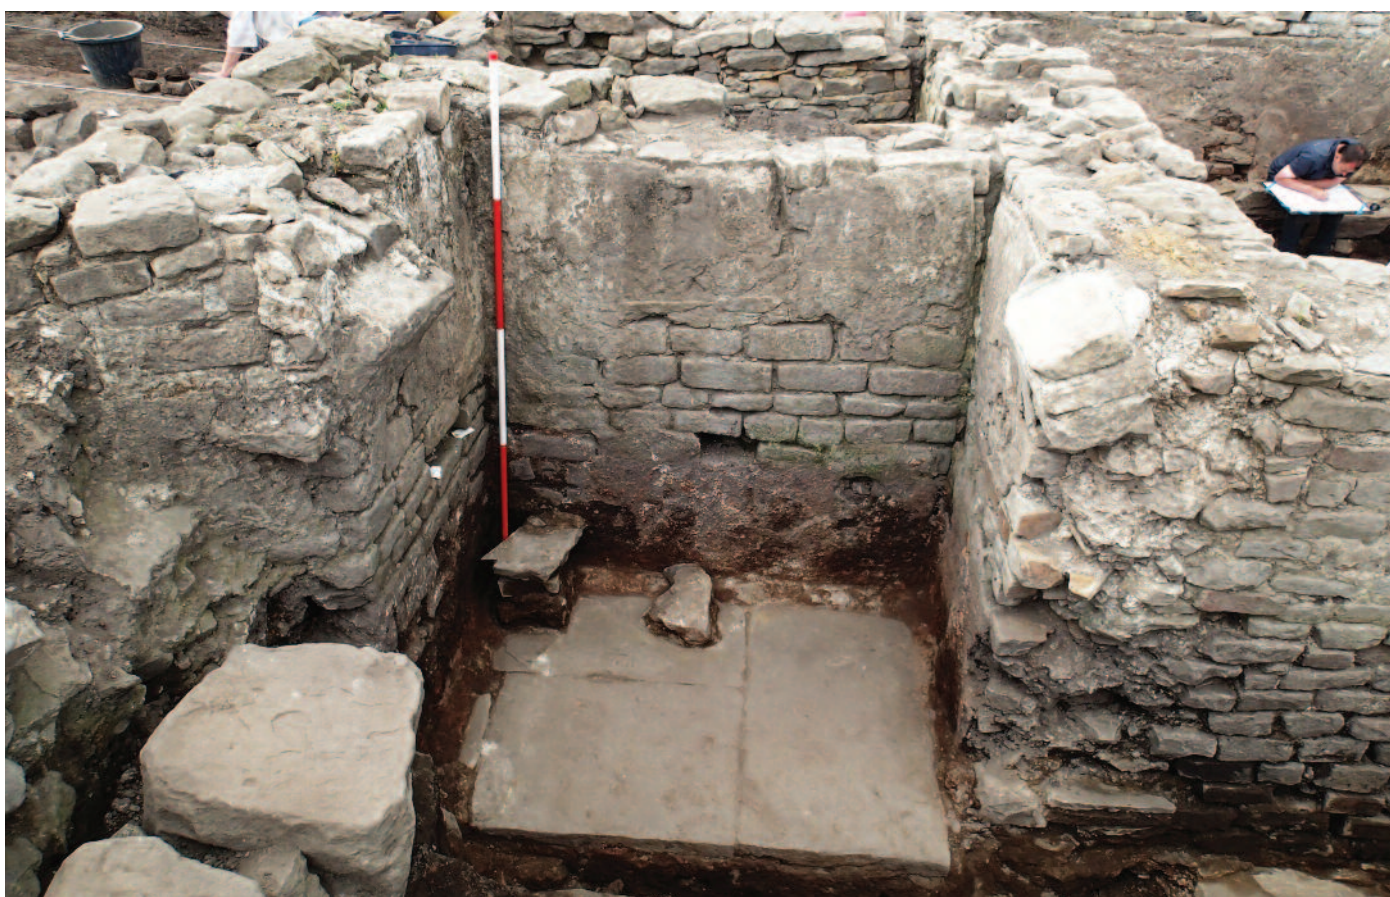
18. Labrum chamber in north part of extension at west end of corridor; note surviving haunches of arch at front.

about 1.5 m above floor level (18). The haunches of the arch at the front still survive. Its floor consisted of two massive slabs of stone neatly fitting up against the quarter-round concrete mouldings at the base of its walls. It may have housed a free-standing pedestal wash-basin or labrum though no trace of such remained.
