New Excavations at Binchester: Results of the 2014 Season

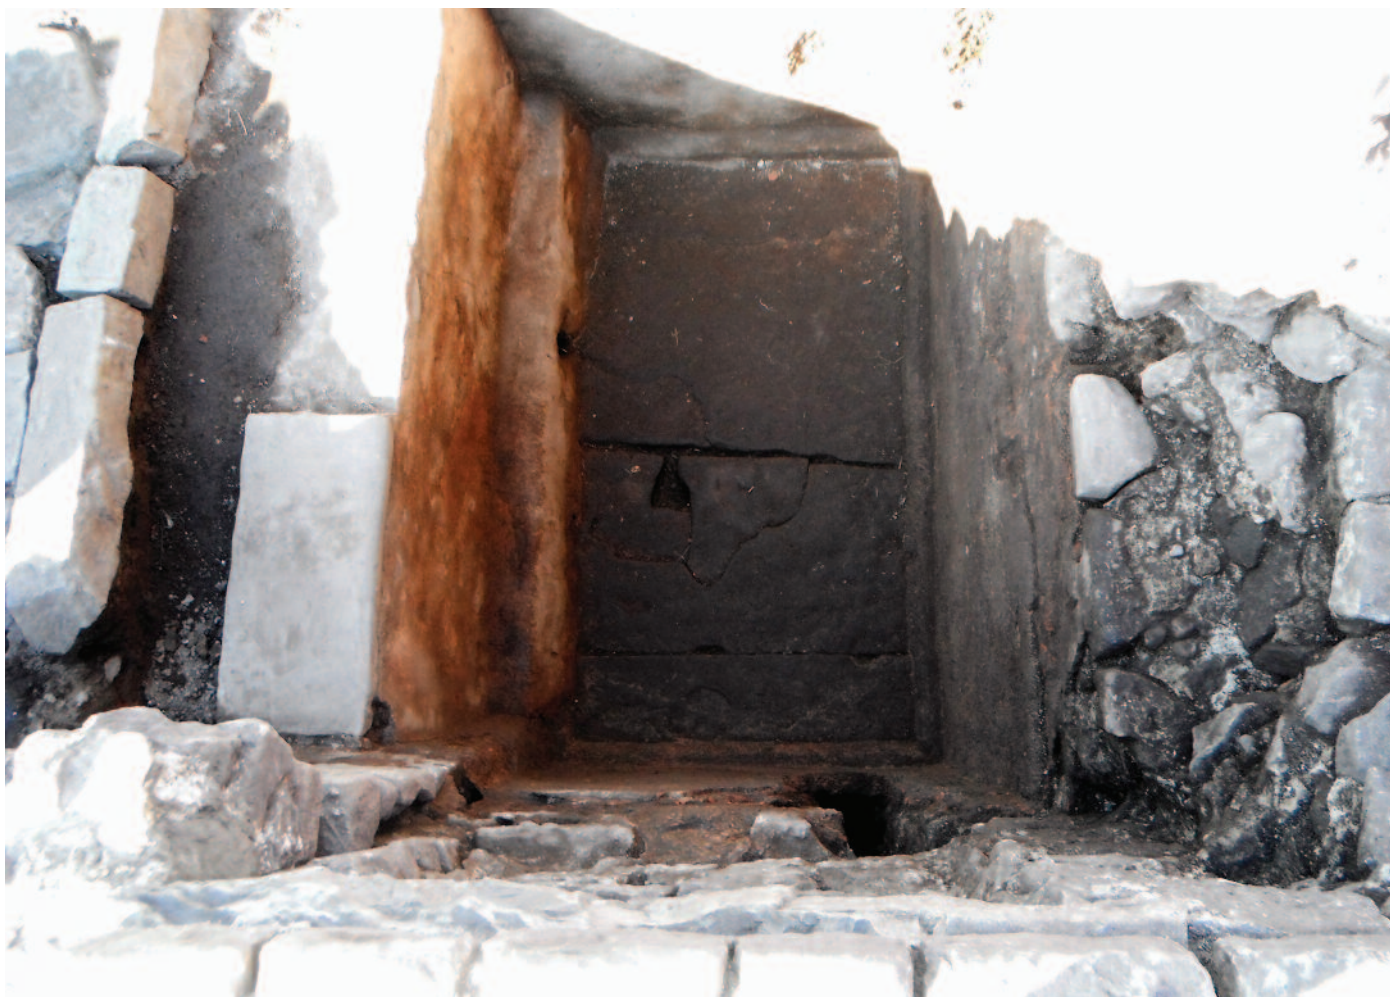
19. Small plunge-bath in south part of extension at west end of corridor.

A similar recess now opened off the south side of the corridor, this one containing a 0.95 m deep plunge-bath sunk partially below floor level with a low and narrow step/bench on the floor against the corridor (19). Measuring approximately 2 x 1 m, and thus usable by only one or two people at a time, this was lined with waterproof concrete with a quarter-round moulding around the edges of the floor. The base was formed of two large stone slabs which may originally have been covered with a lead sheet. In the centre of the north side at floor level was a drain-hole which allowed the waste water to flow into a drainage culvert running below the corridor floor (20). This

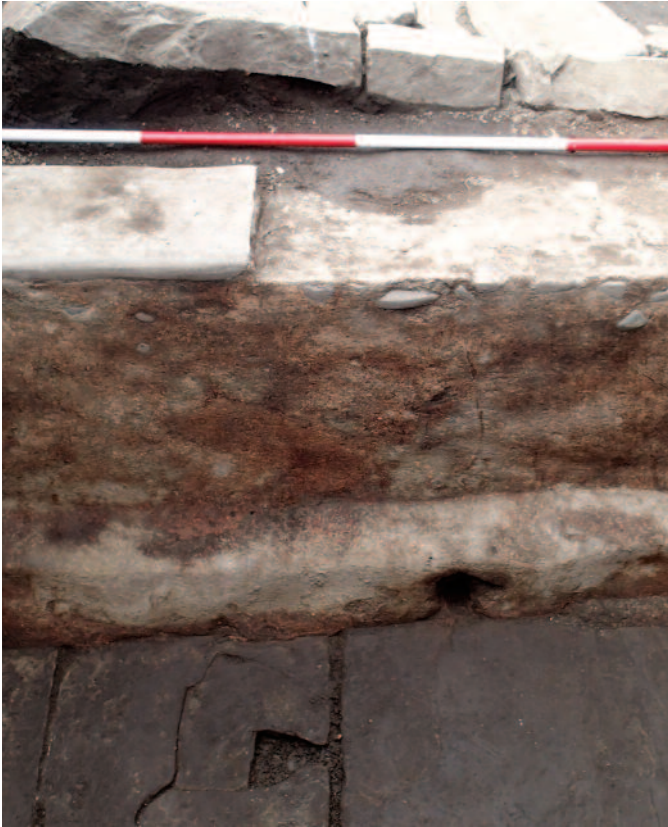
20. Drain-hole in floor of plunge-bath shown in image 19.

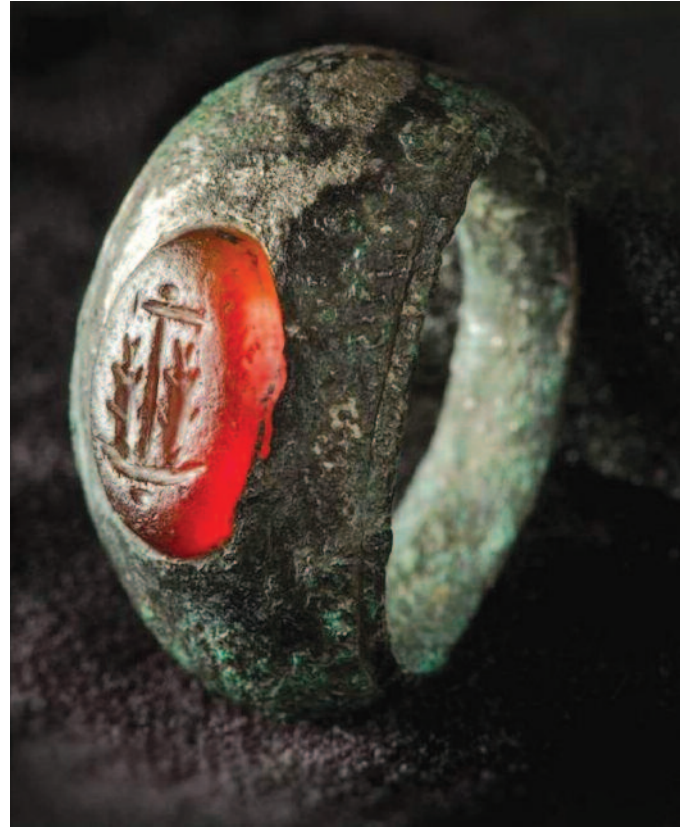
22. Silver ring with cornelian gemstone carved with anchor and fishes Christian symbol.

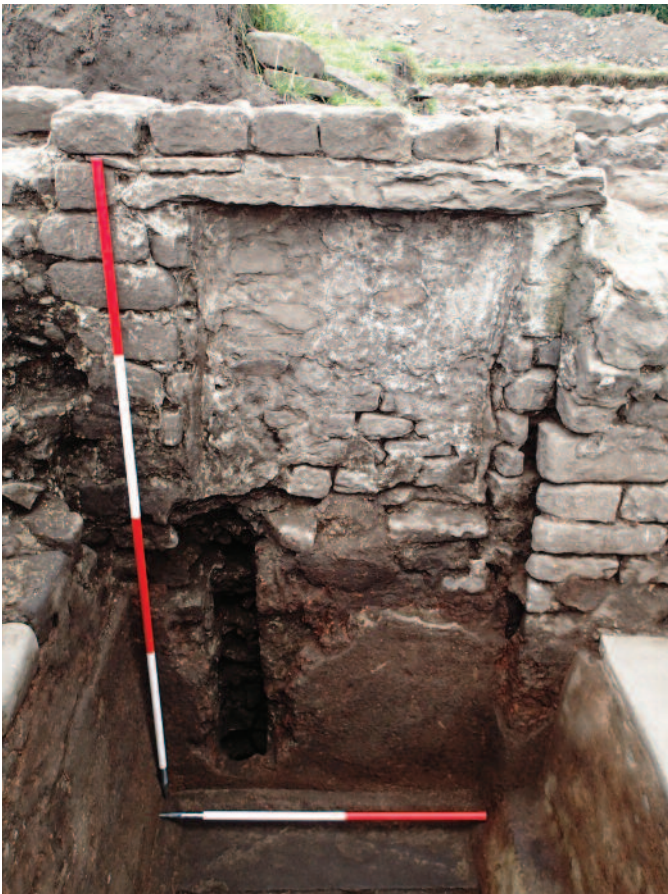
21. West wall of plunge-bath showing blocked-up window and damage resulting from the robbing-out in antiquity of a lead water pipe (?).

passed beneath the original blocked-up doorway in the north wall of the corridor, continued across the apodyterium where it was joined by an outflow from the large plunge-bath inserted in this room, and then changed course to exit beneath the doorway in the east wall. A roughly cut vertical channel in the south-west corner of the bath suggests the crude robbing-out of some fitting. The upper end of this feature lay at the same height as the top of the upper step at the front of the bath suggesting that it was connected with the water level in the bath. Most likely it contained a lead pipe either supplying water to the bath or functioning as an overflow. The west wall of this chamber featured a small window 0.90 m wide internally and with a maximum height of 1.10 m which had been blocked-up at a later stage (21).
