Appendix B – Risk Assessment

Appendix B - Risk Assessment

B.1.1 Introduction

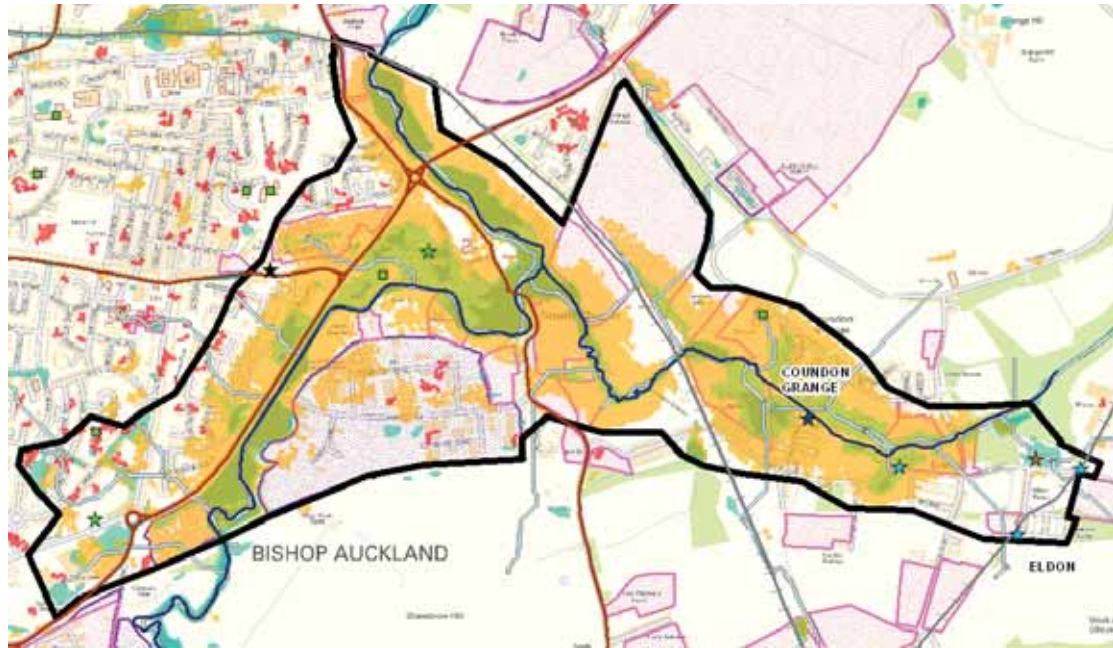
SITE BIS3 – BISHOP AUCKLAND

Whilst the current surface water risk seems to be under control, the residual risk in exceedance events remains, affecting approximately 1000 properties and requires consideration by the SWMP. This SWRA will be carried forward to the Options phase.

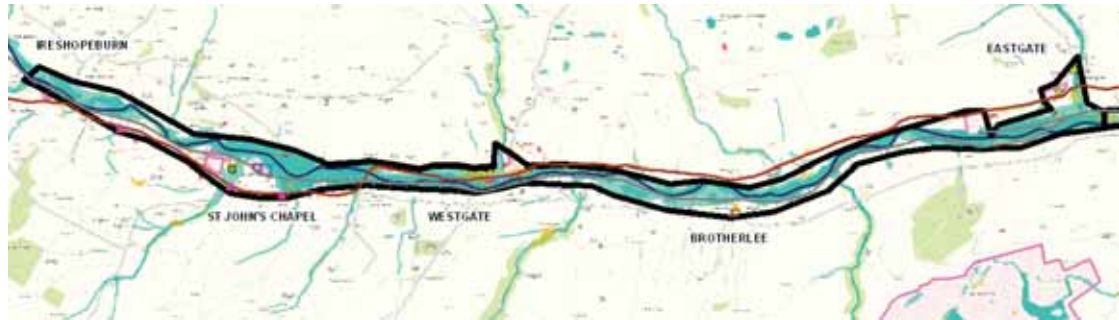
**SITE RAIL3 – RAILWAY LINE BETWEEN IRESHOPEBURN AND BLACKETT’S GILL
WESTERN SECTION – IRESHOPE BURN TO EASTGATE**

<p>CONCLUSIONS</p> <p>Critical infrastructure is largely at risk in this SWRA with three sections of railway line and three main roads (A689, B6278 and B6296) at surface water risk.</p> <p>It would be possible to address the areas where critical infrastructure is most at risk from surface water flooding as well as the residual risk along discrete sections of the SWRA as part of the Options phase.</p>
